## Blackduck City Council - Work Session Meeting

6:00 PM - Monday, October 24, 2022  
City Hall, 8 Summit Drive, Blackduck MN

| | Page |
|---|---|
| c. Kitchigami Regional Library Capital Appropriation Project - Discussion on Purchase Agreement for 17 Summit Ave and Real Estate Inspection Report<br><a href="#">FullReportForUpload</a><br><a href="#">Draft - Certificate of Survey - Library</a><br><a href="#">Deerwood 10-4-22</a> | 15 - 112 |

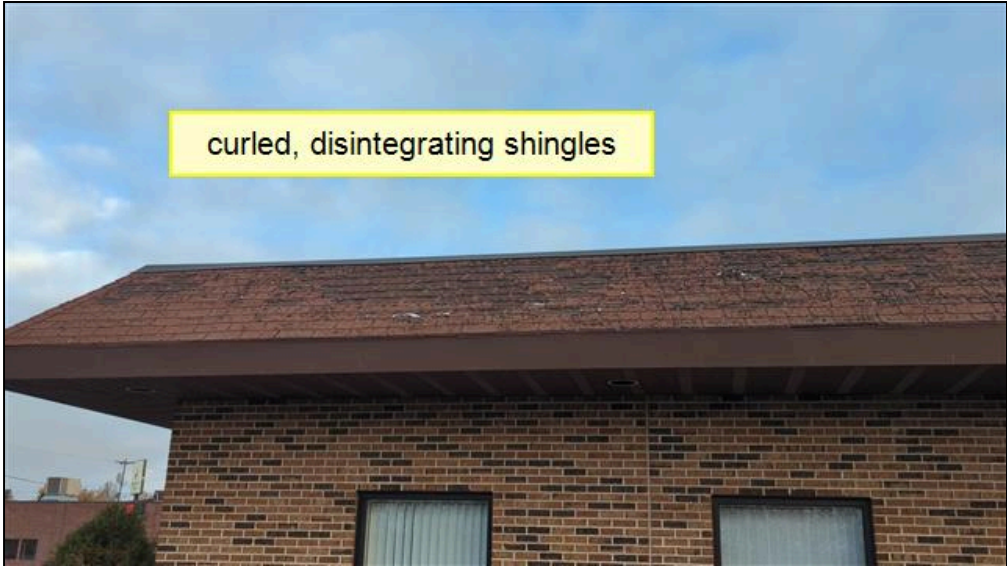
1.0 Item 1(Picture) S eave

**Comments:** Inspected, Tradesman Recommended  
The shingled eave and drive-up awning roofing is at the end of its service life and should be replaced immediately. The rubber membrane roofing appears to be sound, but is likely near the end of its service life. Seam and junction sealant is cracked. Membrane bridging/adhesive separation is present at parapet junctions. Have a qualified roofer assess and repair or replace the roof coverings.

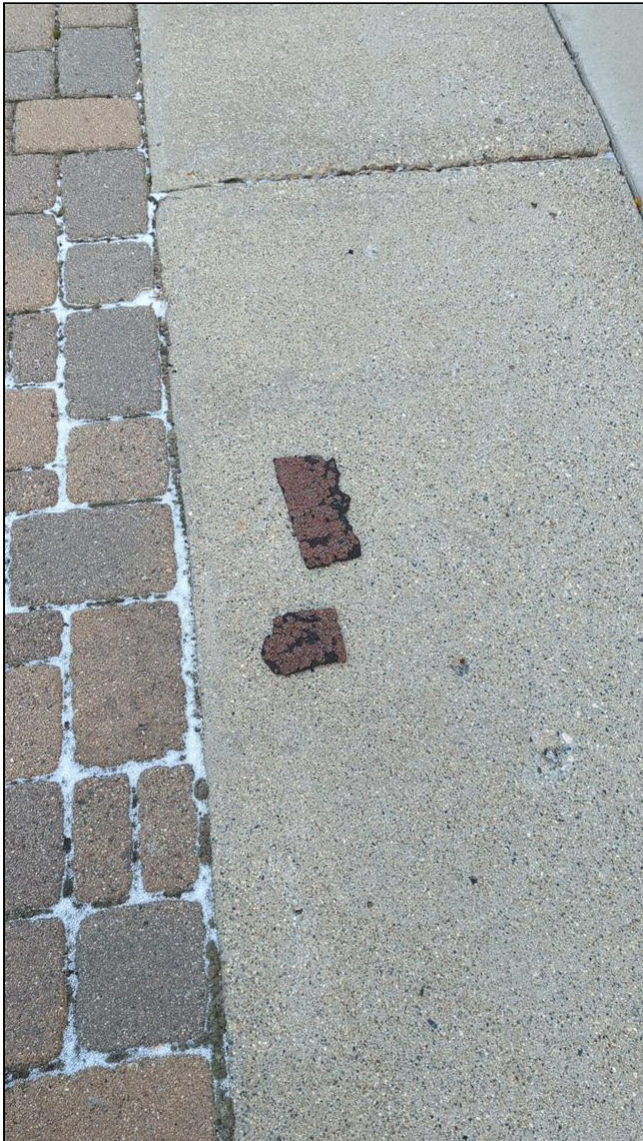
1.0 Item 3(Picture) shingle material on ground

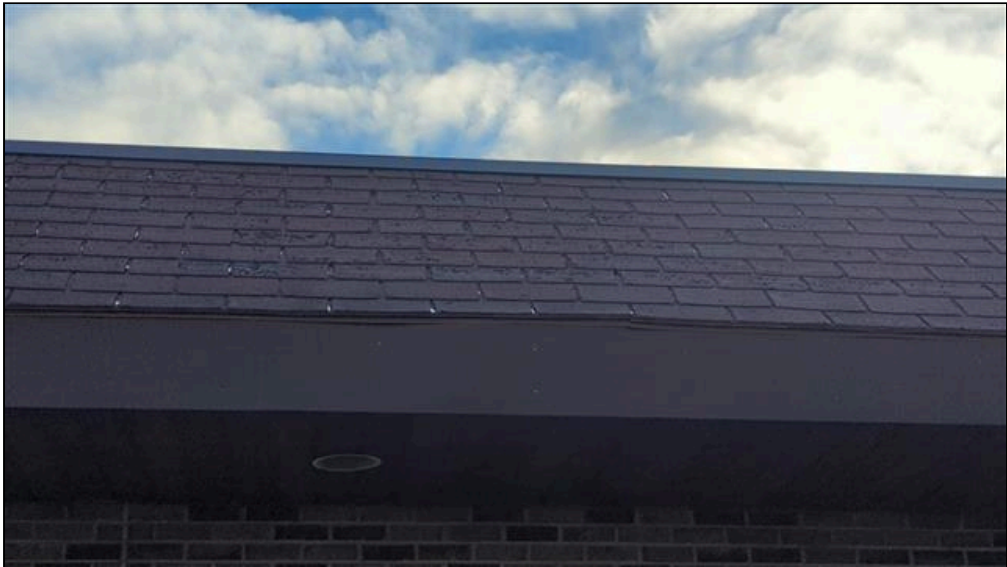
1.0 Item 4(Picture) W eave

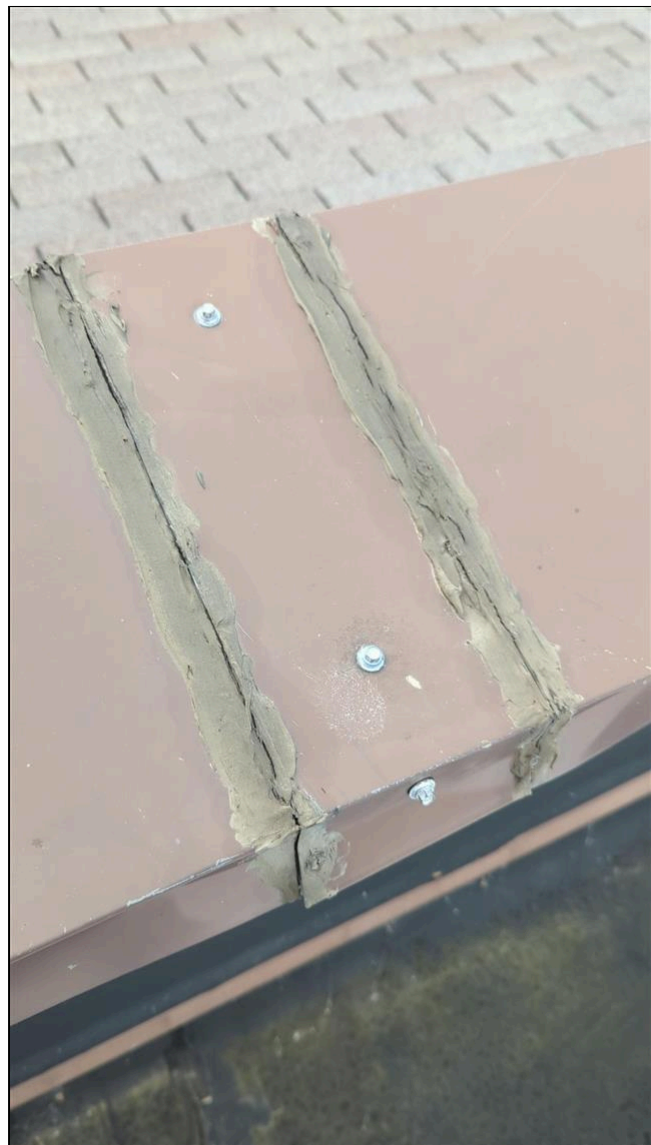
1.1 Item 1(Picture) protruding nails

**Comments:** Inspected, Tradesman Recommended  
Re-set fascia flashing nails, re-secure and seal parapet coping junctions and parapet flashings. There is a poorly sealed

curb cover over LP piping and electrical conduit on the roof.

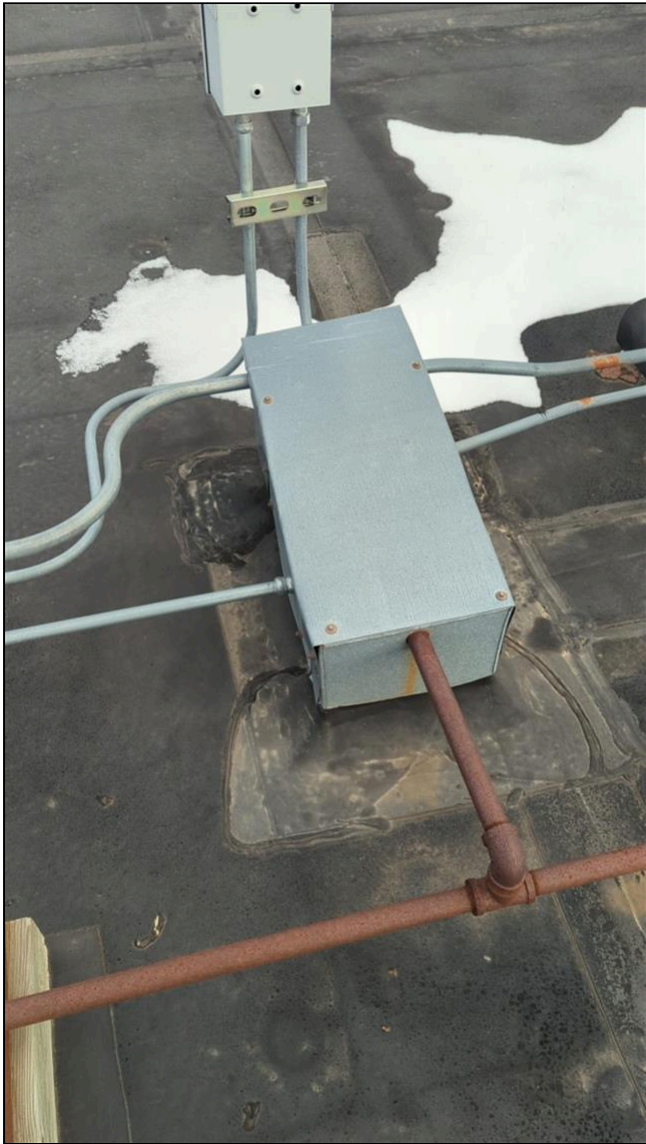
1.1 Item 7(Picture) Poorly sealed curb cover

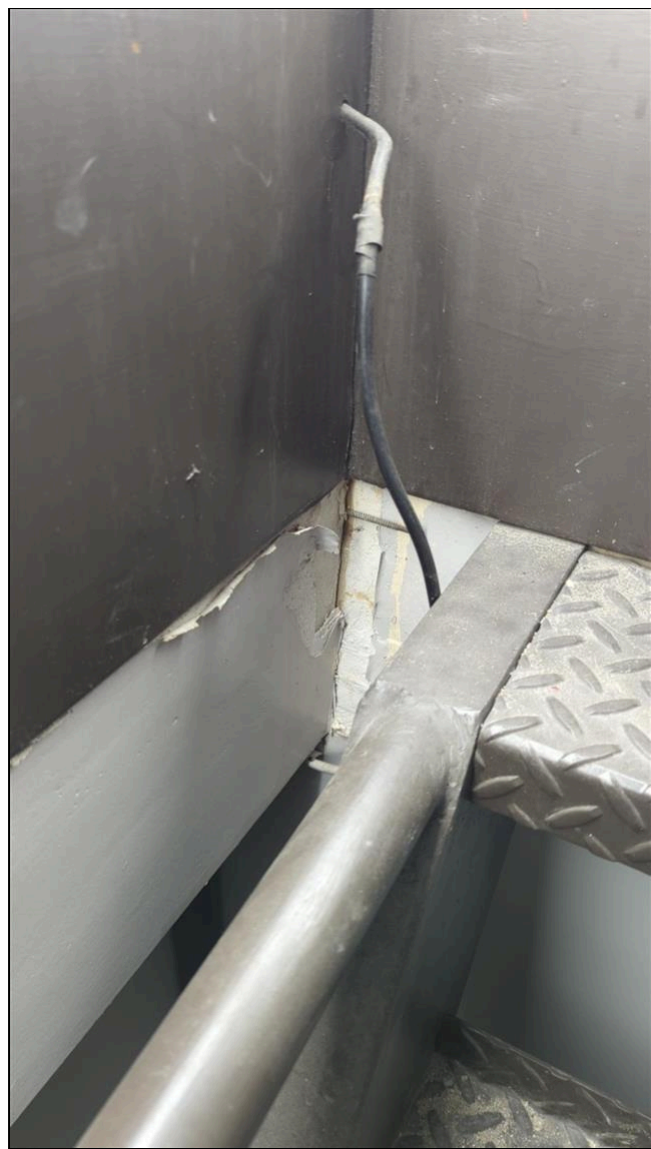
1.2 Item 1(Picture) inside roof access hatch

Peeling paint inside the roof access hatch indicates possible poor insulation or curb leaks.

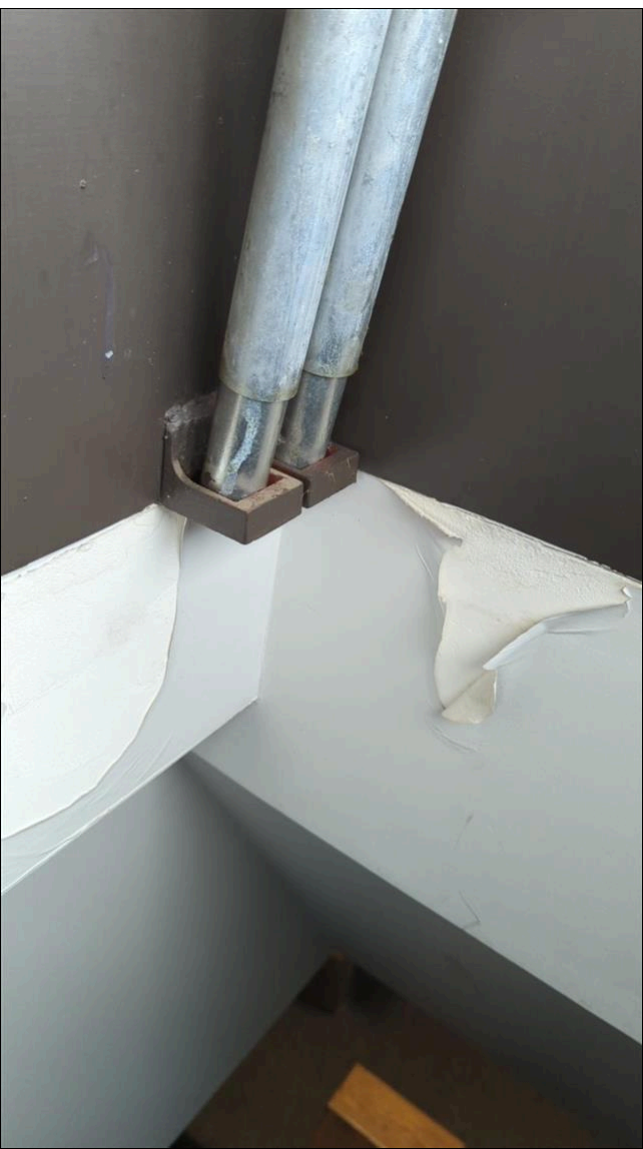
1.2 Item 2(Picture) inside roof access hatch

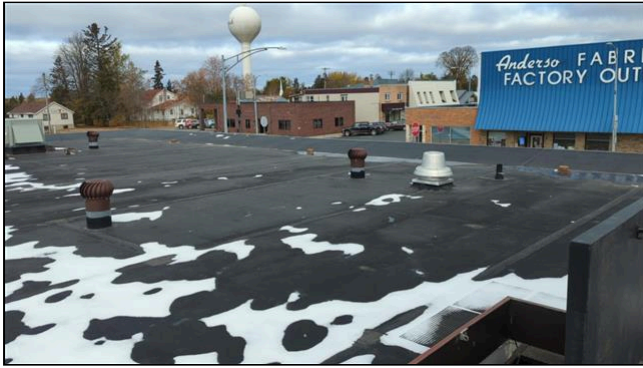
1.3 Item 1(Picture)

Roof drains appear to be at appropriate locations. There are no over-flow scuppers present on the roof to drain water in the event of plugged or frozen drains.

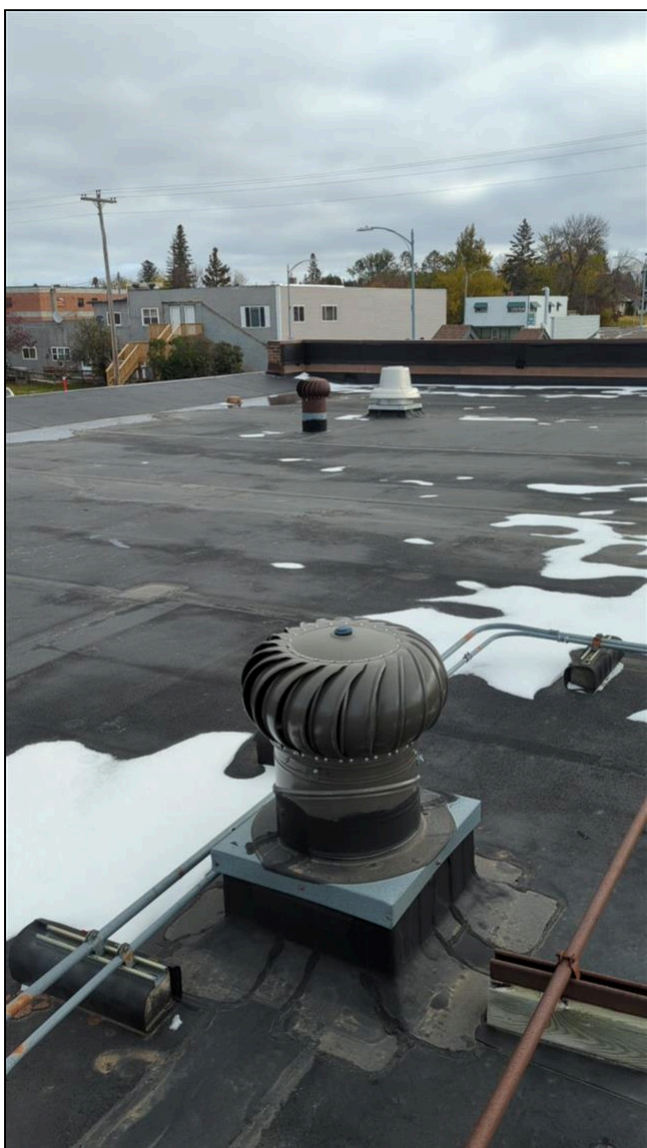
1.6 Item 1(Picture)

Turbine venting is present on the roof top, indicating that open attic space is ventilated.

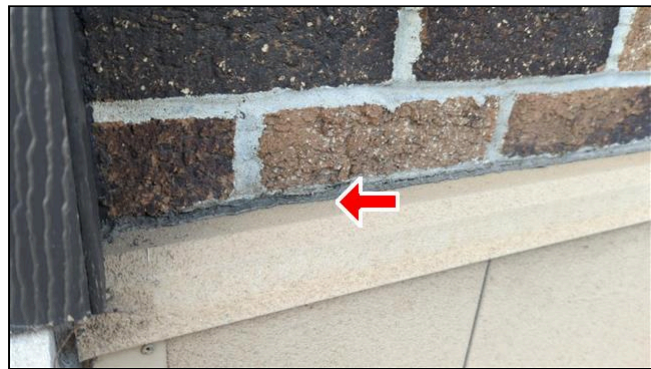
2.0 Item 1(Picture)

Re-seal flashing bead between brick and metal siding on N side of building. Seal/flash wide expansion joint between the exterior sidewalk and parking lot curbs and the S wall of the building. Deterioration is observed on the wood siding on the drive-up teller awning.

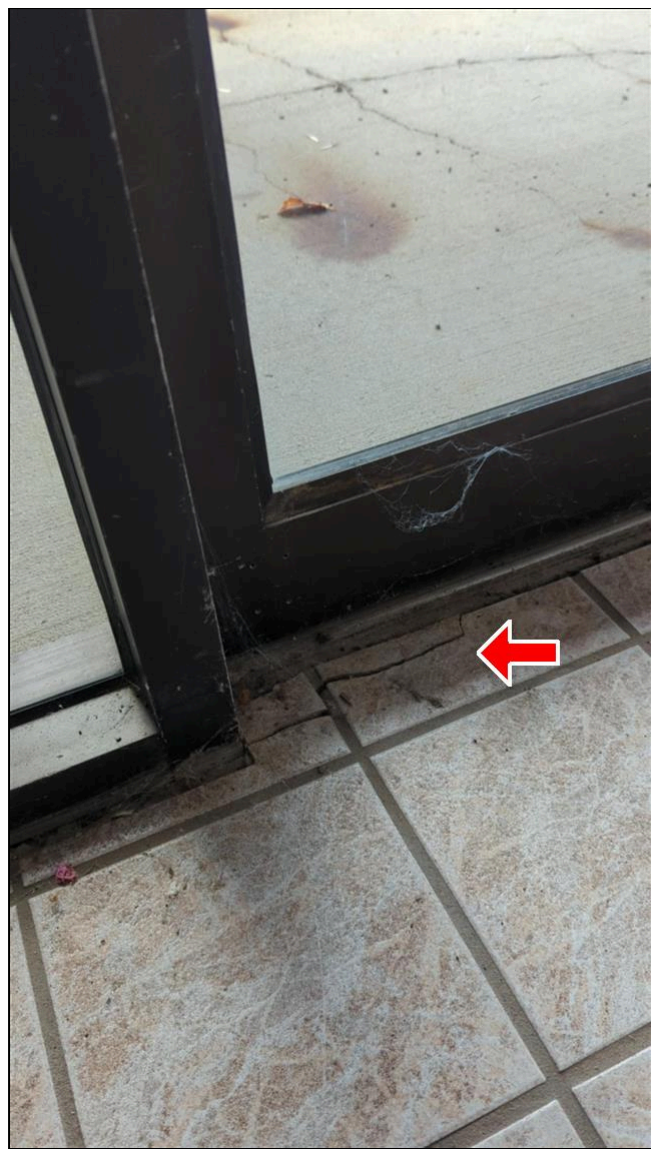
2.1 Item 1(Picture) back entry

The exterior door sills do not seal well, causing air intrusion and damage to the floor covering.

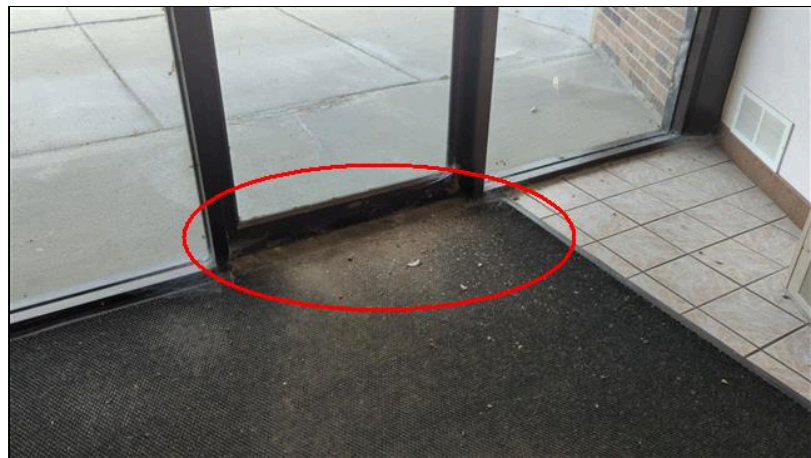
2.1 Item 2(Picture) front entry

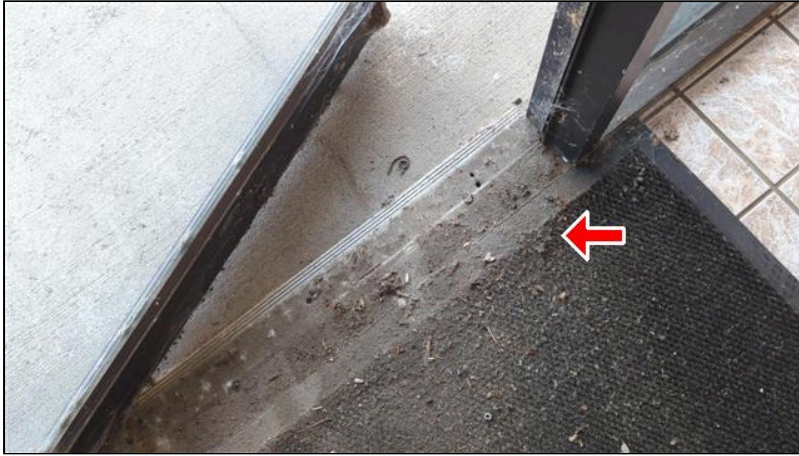
2.1 Item 3(Picture) front entry

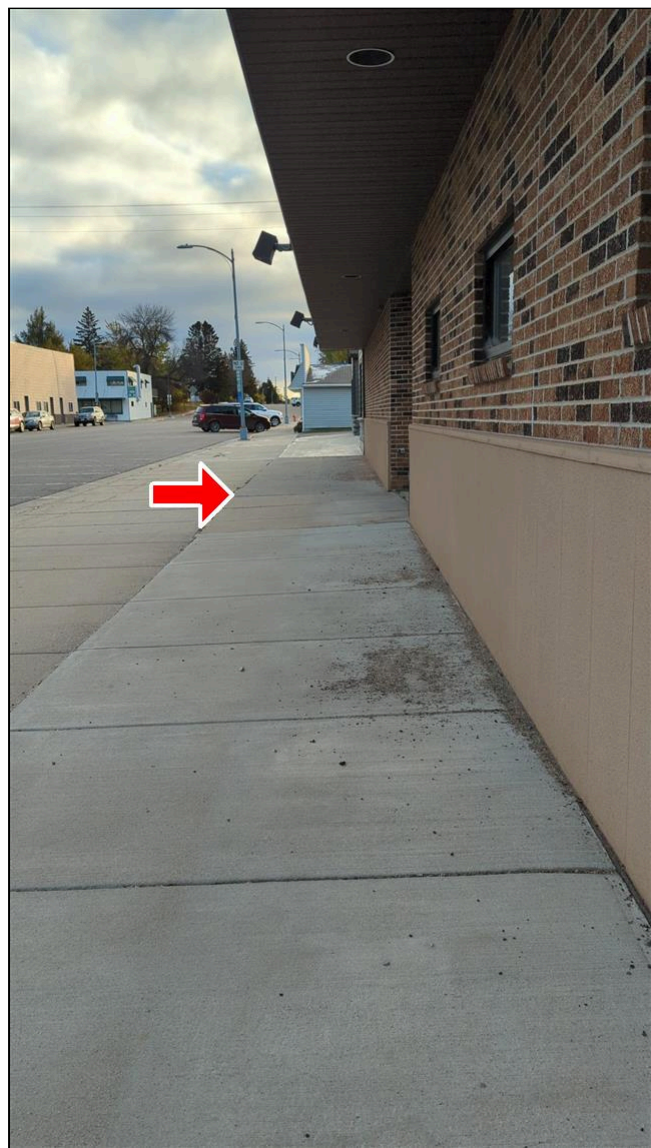
2.5 Item 1(Picture) low to negative pitch

The sidewalk on the NE end of the building appears to have flat to slightly negative pitch-drainage should be monitored. The brick patio area on the W side has settled bricks and a variable surface. There is a deteriorated piece of dimensional lumber next to the S side entrance sidewalk. There is an uncovered cast iron sleeve in the sidewalk on the W side of the building that appears to be allowing moisture intrusion and possibly causing freezing and heave on the sidewalk

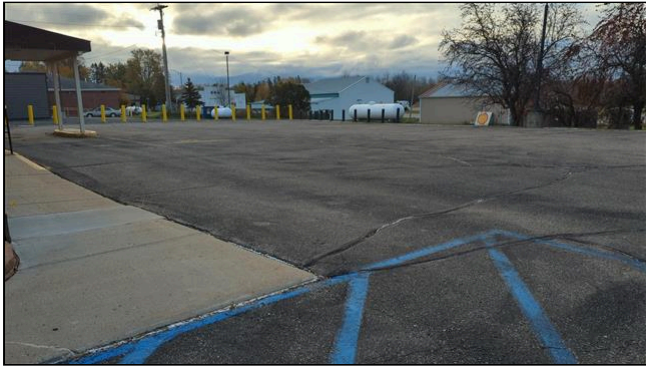
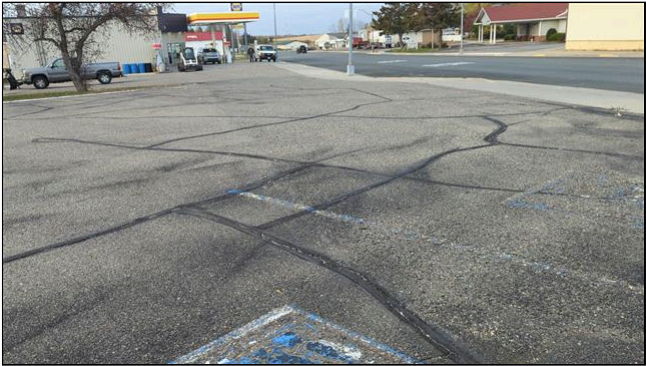
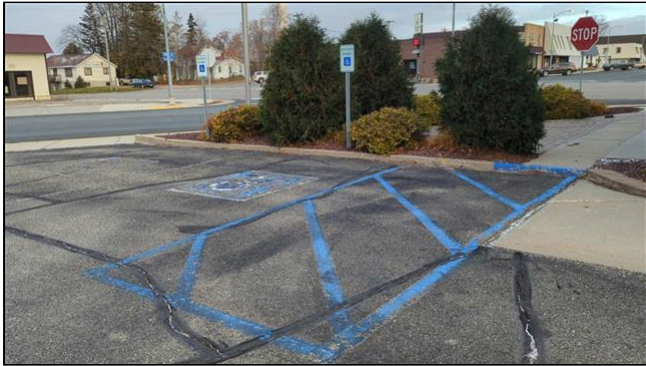
2.6 Item 1(Picture)

The parking lot is in serviceable condition and appears to have appropriate drainage pitch away from the building, to the S side of the property. Consider seal-coating and sealing cracks in the asphalt.

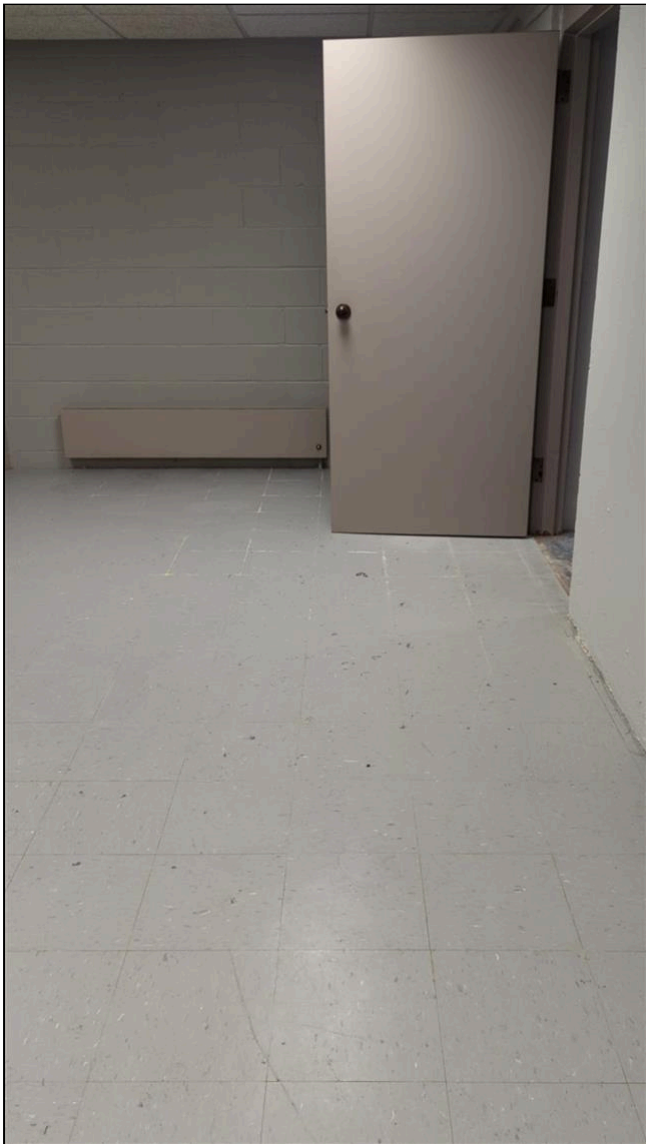
Evidence of past moisture presence is observed in the basement - loose/stained floor coverings may be due to past water supply leaks, efflorescence, peeling and stained paint, stained items stored on the floor may be due to moisture intrusion on the S side of the building's exterior due to poor drainage. Have a licensed plumber present to assess the water distribution system when re-connected. Have a qualified contractor assess the exterior drainage, flashings, and building seals on the S side of the building's exterior.

3.0 Item 1(Picture) loose floor tiling

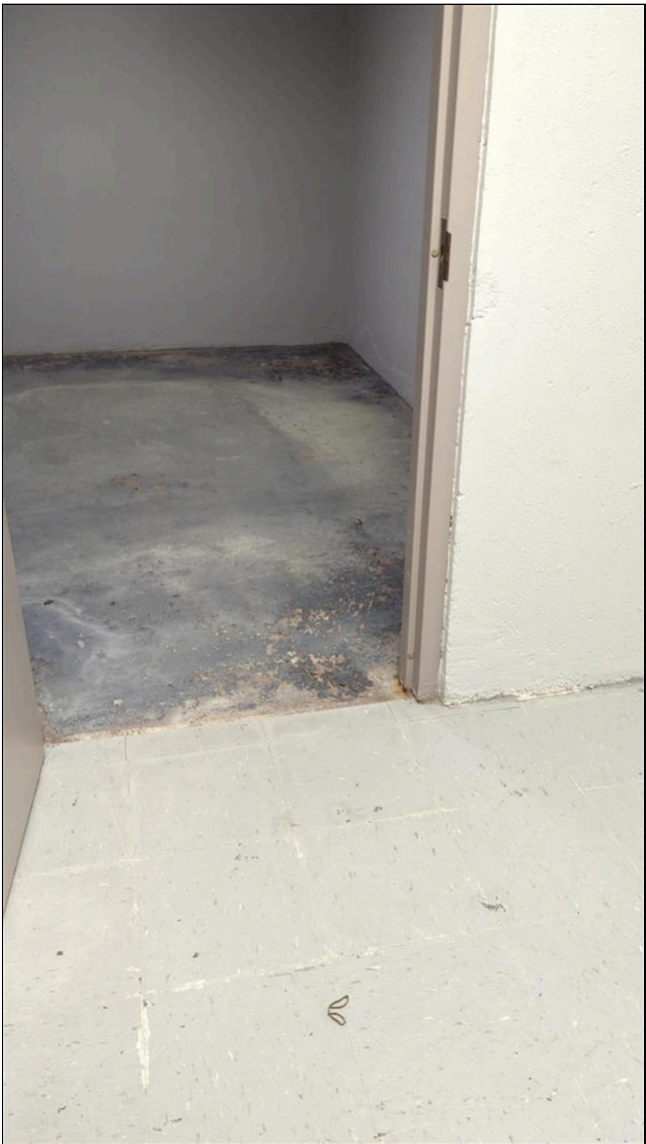
3.0 Item 2(Picture) peeling floor paint

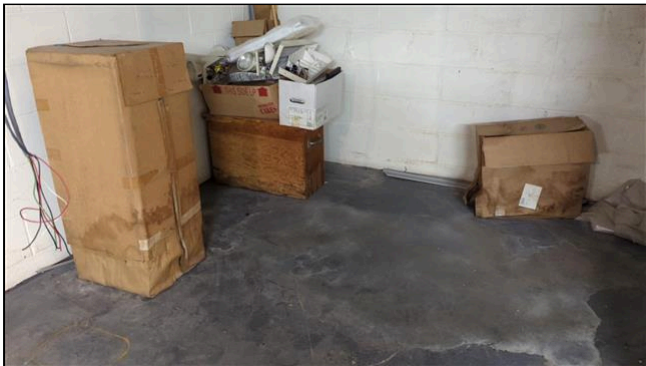
3.0 Item 3(Picture) stained floors and cardboard items

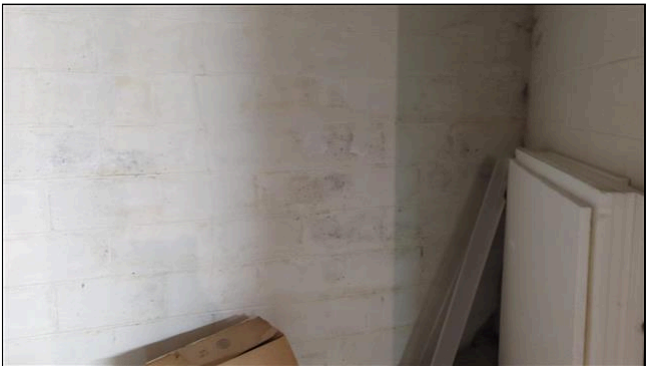
3.0 Item 4(Picture) wall stains/efflorescence

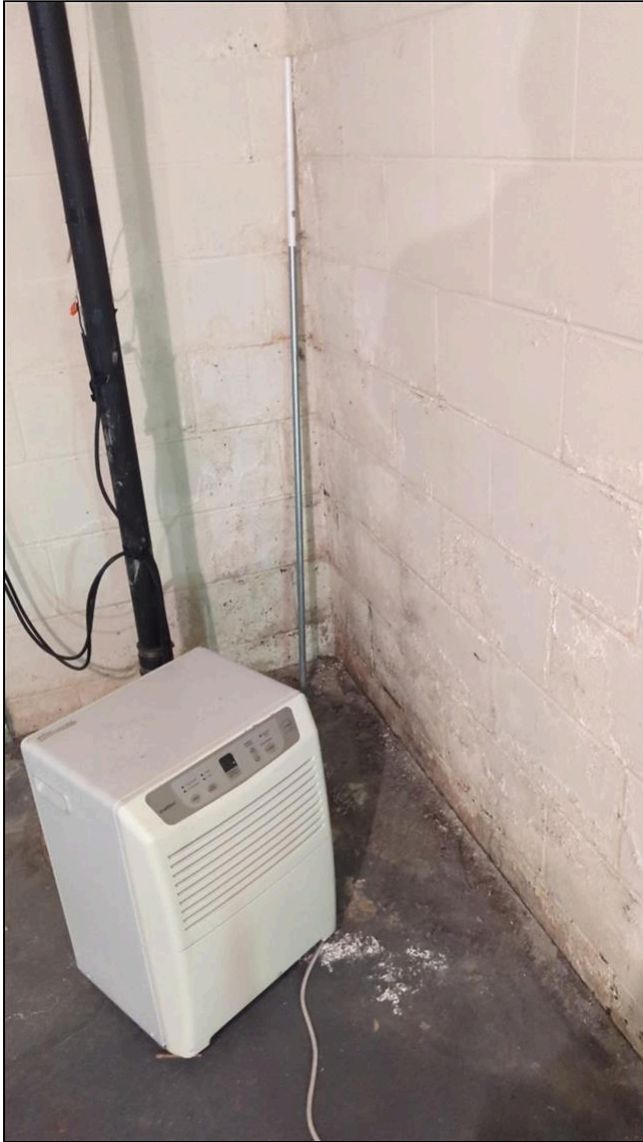
3.0 Item 5(Picture) condensation/airflow staining

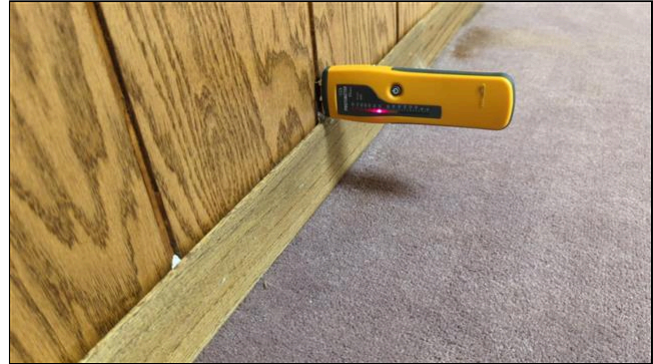
3.0 Item 6(Picture) high moisture content wall paneling

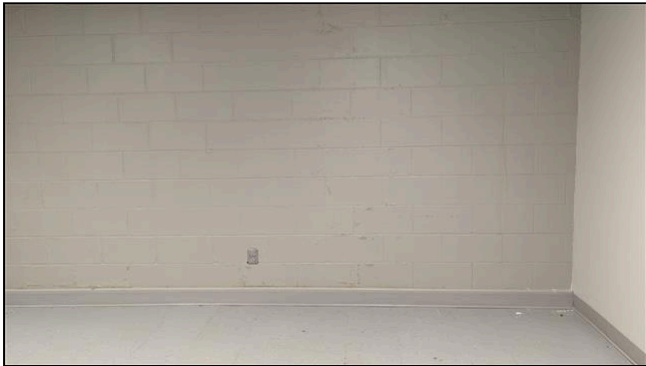
3.0 Item 7(Picture) stains and peeling wall paint

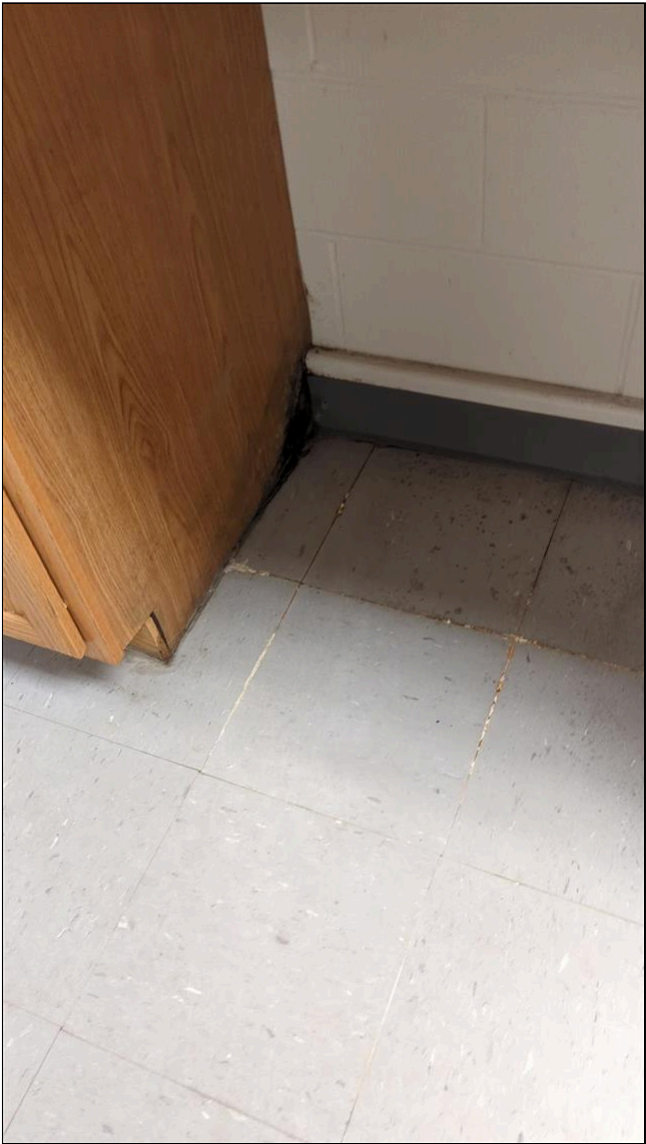
3.0 Item 8(Picture) stained cabinet base

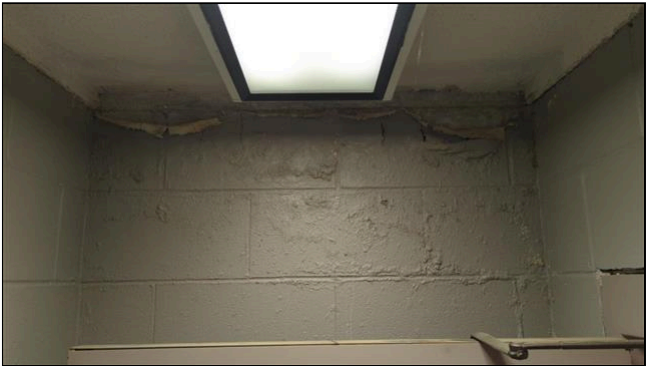
3.0 Item 10(Picture) stains/peeling wall paint

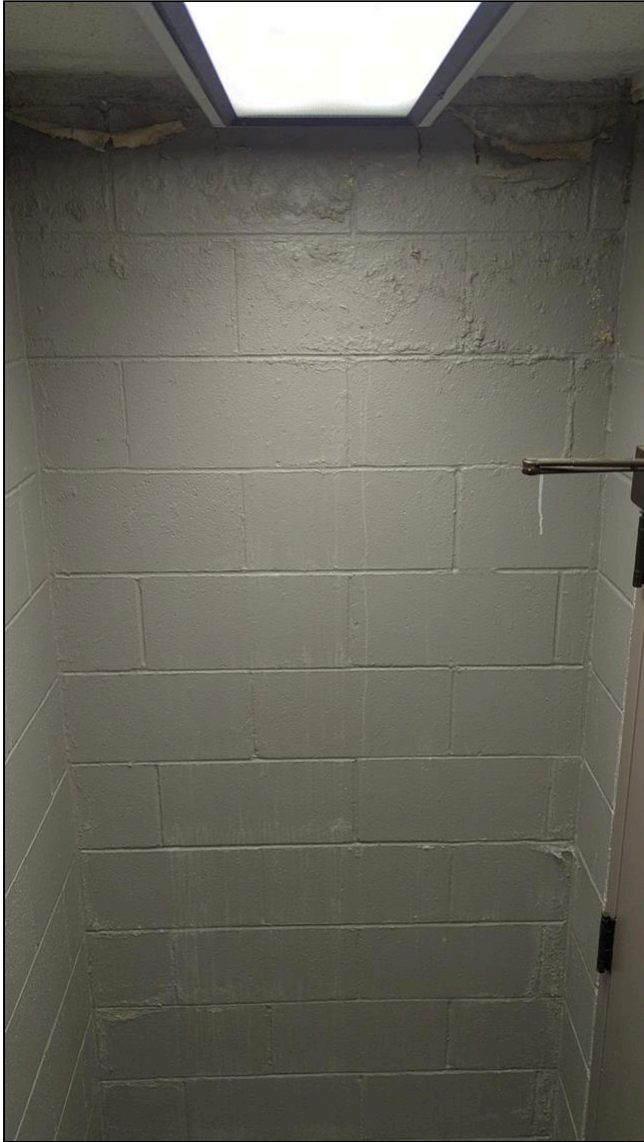
3.0 Item 11(Picture) south stairwell

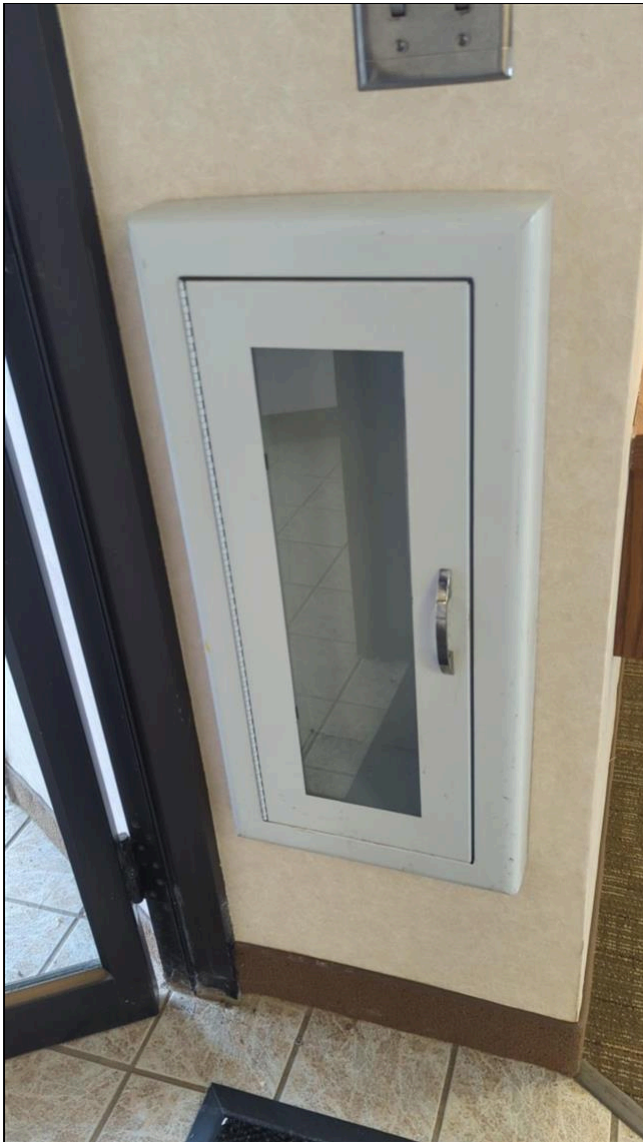
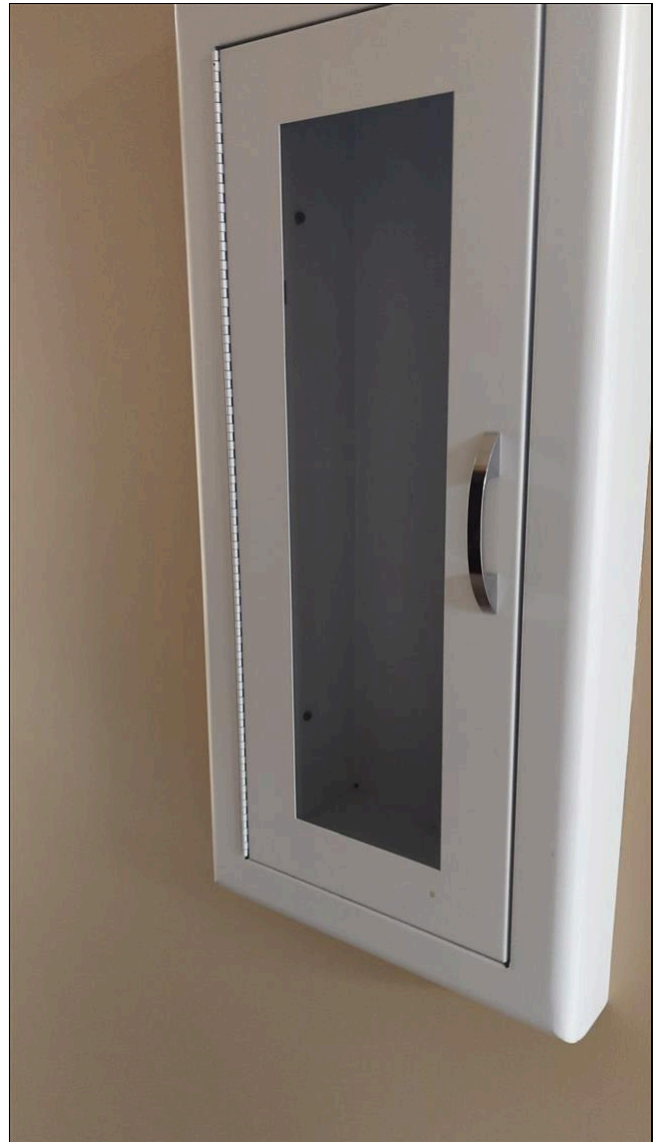
3.1 Item 1(Picture)

Re-install fire extinguishers where they are accessible within 75' of all areas of the building.

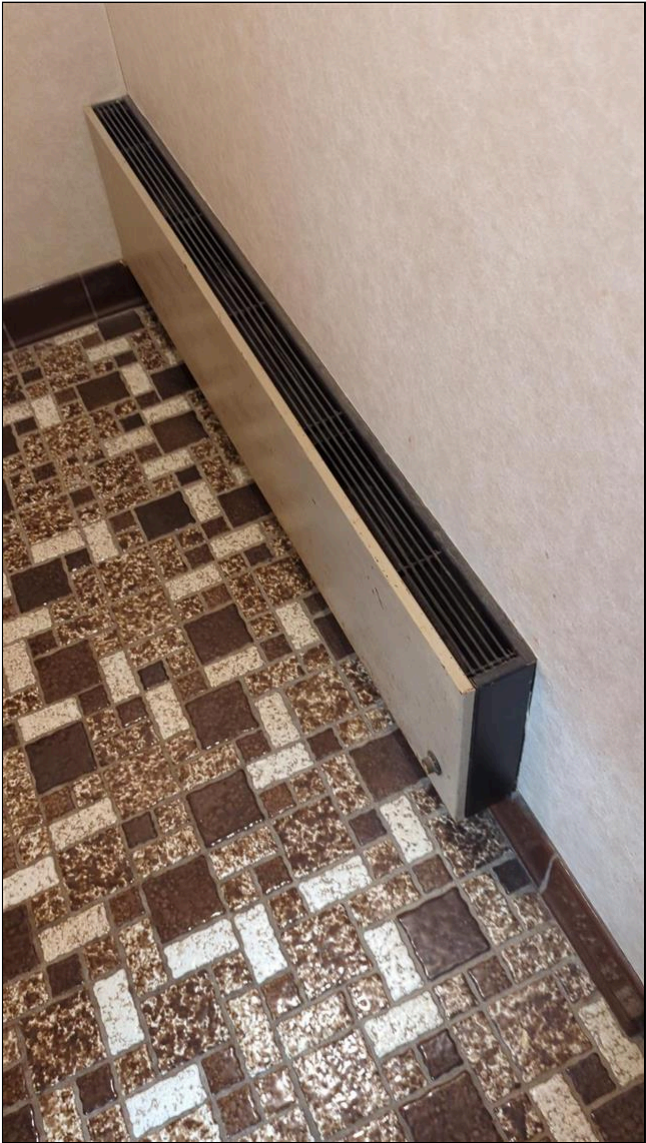
4.0 Item 2(Picture) electric in restrooms

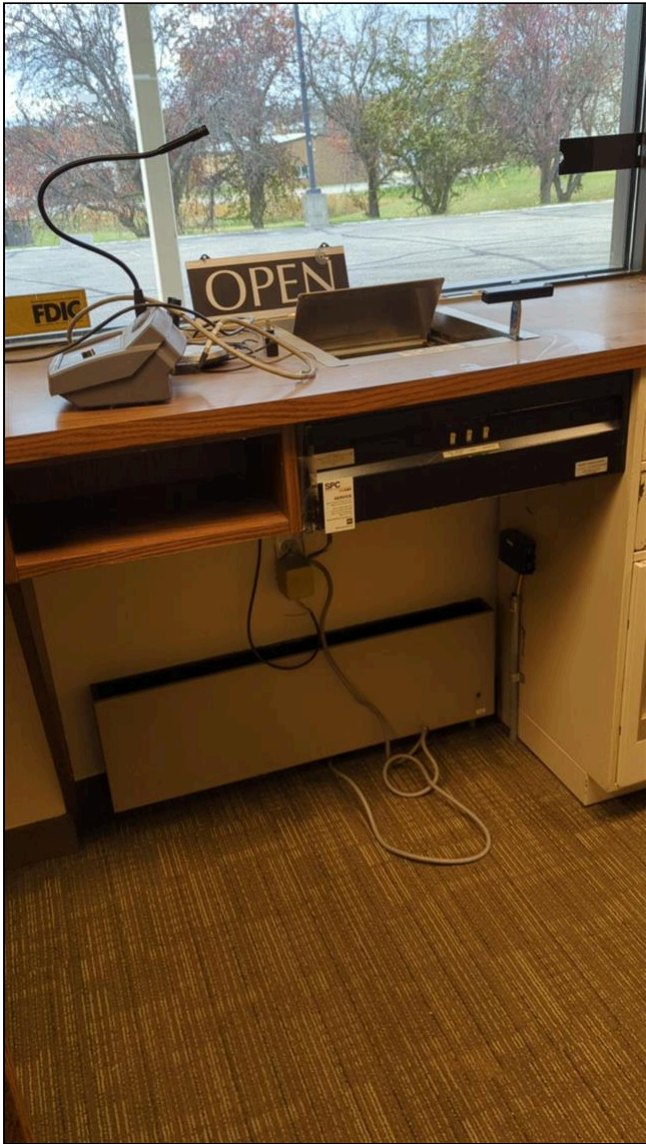
4.0 Item 3(Picture) drive up window

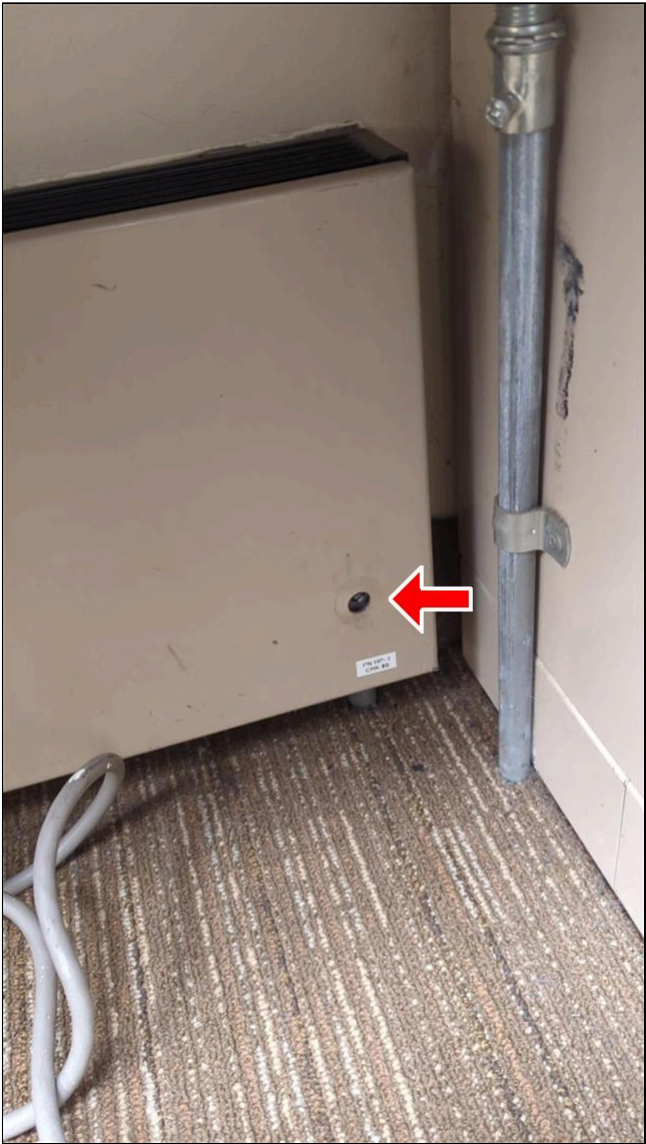
4.0 Item 4(Picture) drive up teller window

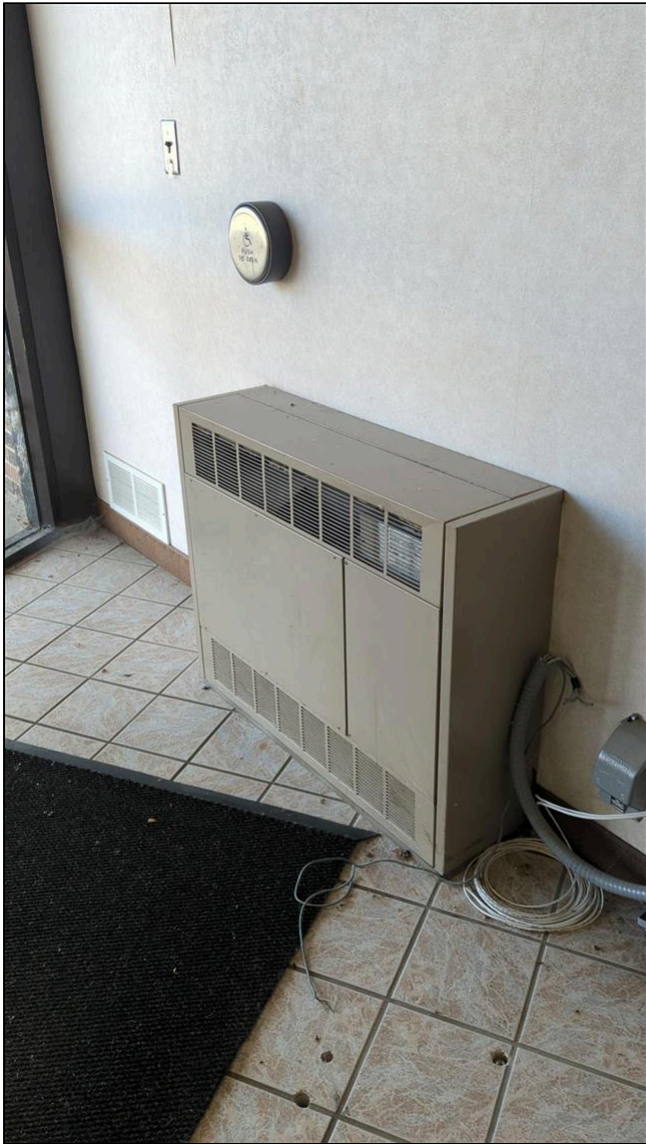
4.0 Item 5(Picture) entry vestibule

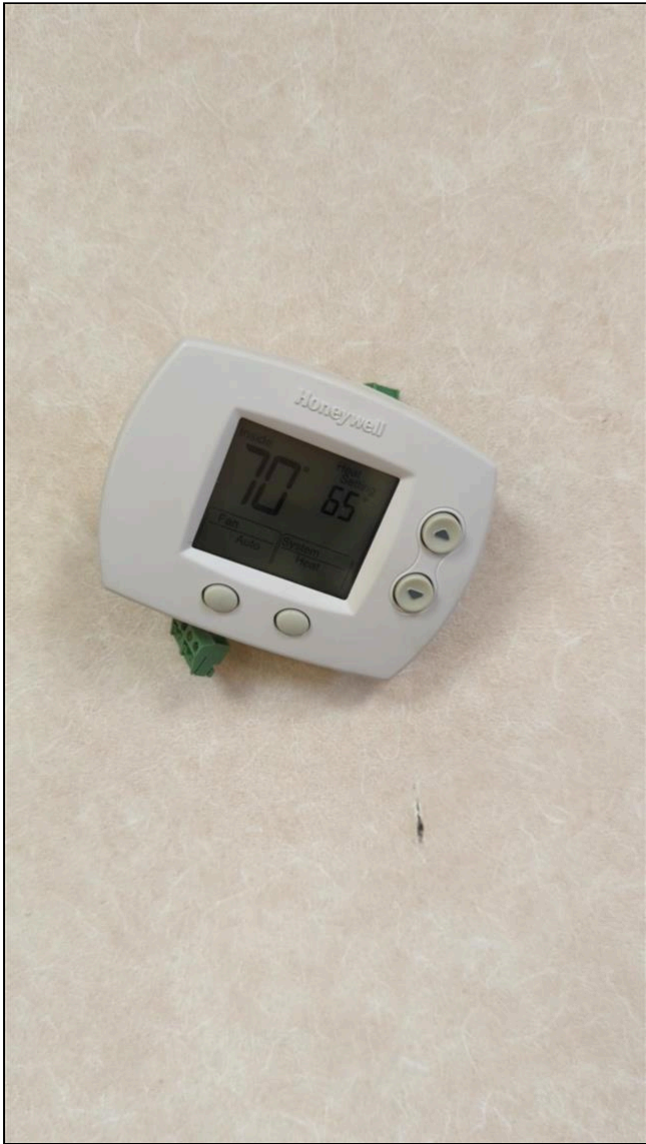
The E unit is controlled by the thermostat on the S wall of the interior teller area. The unit is not securely attached to the wall, and is separated from the back work area space that it also heats/cools. This may cause inconsistent heating balance on the E end of the building. The W end unit is controlled by multiple thermostat zones with temperature sensors. The W end offices were all at different temperatures and the common space was also inconsistently heated. The heating system is not well balanced and should be re-balanced by a qualified HVAC technician. The basement heating units are individually controlled and the central space has a thermometer on the E wall.

4.1 Item 1(Picture) East unit control

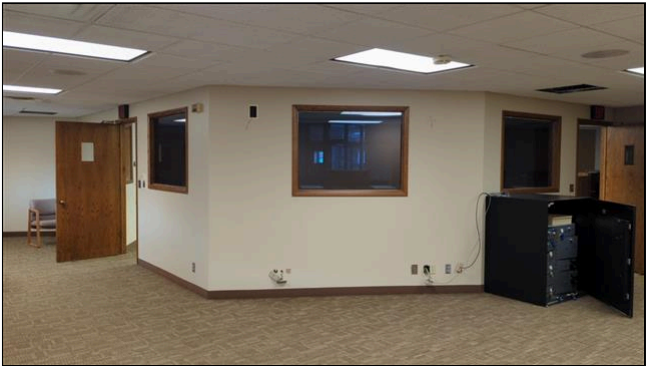
4.1 Item 2(Picture) no thermostat present in back work area?

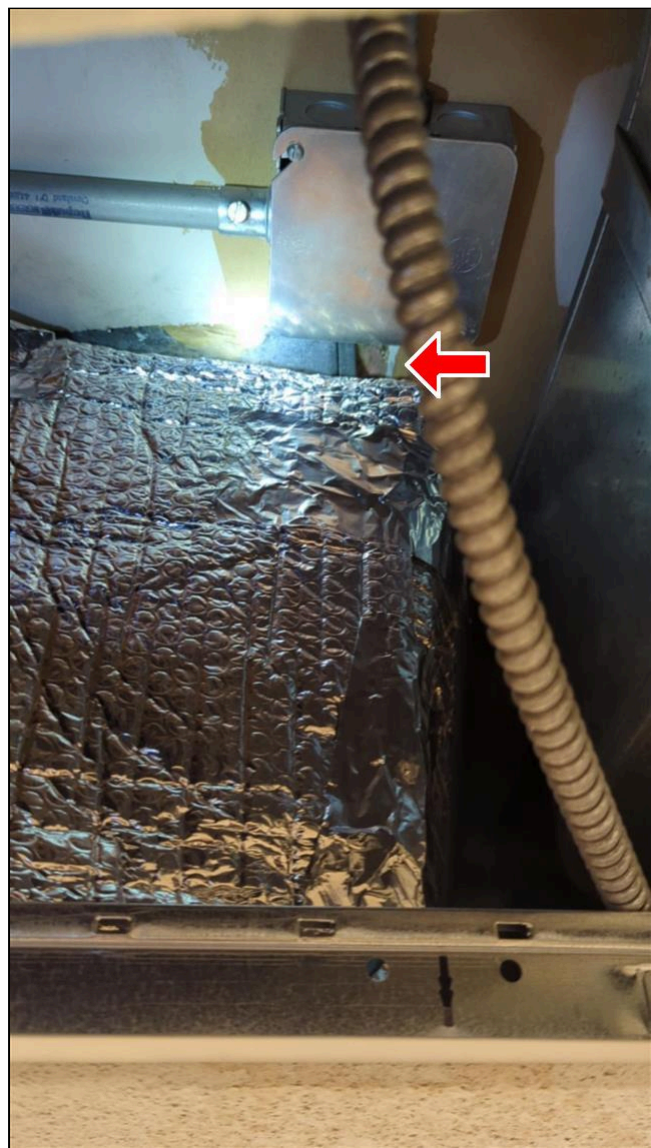
There is a gap in duct insulation above the drive-up teller space that may cause condensation on the distribution system. Retrofit air returns and supply ducts indicate past problems with air circulation and balancing. Consult with a qualified HVAC technician about the best management of supply and return air movement in the building. There is an air exchange system in the lower level, providing fresh air to the lower level conference and break rooms. The unit must be activated manually, consider installing an automatic air exchange control.

4.3 Item 1(Picture) drive-up teller area

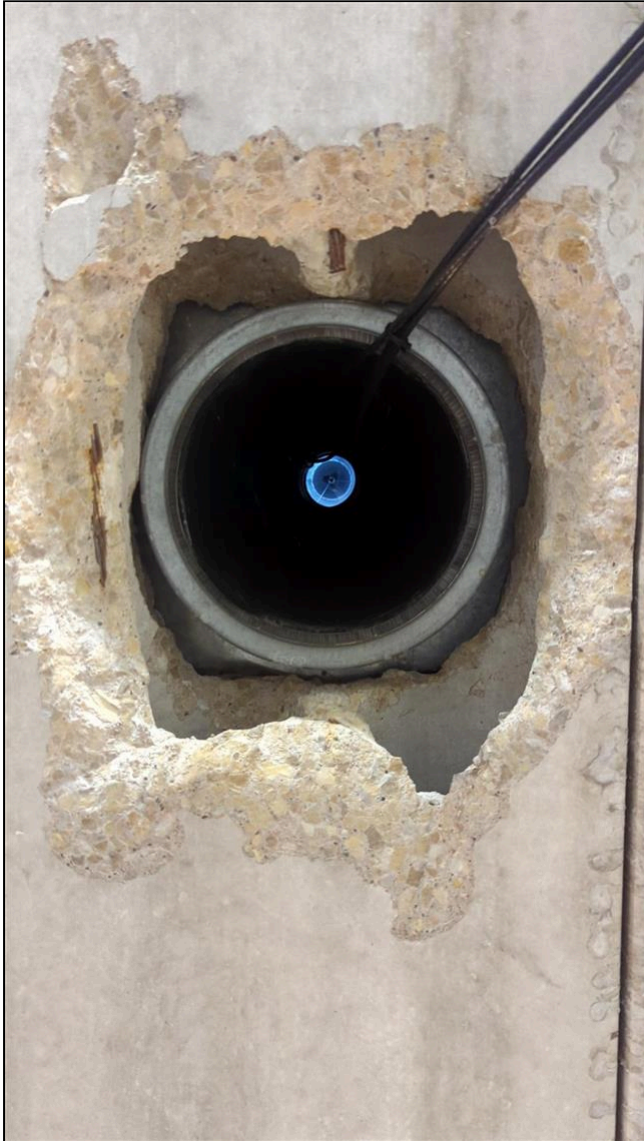
There is a discontinued heating flue in the basement utility room that is open to the exterior at the roof and is serving as a ventilation port. This is a heat loss location that should be insulated and a better mechanical ventilation system should be considered if basement fresh air is required.

4.5 Item 1(Picture) open flue between utility room and roof
