## Blackduck City Council - Work Session Meeting

6:00 PM - Monday, October 24, 2022  
City Hall, 8 Summit Drive, Blackduck MN

| | Page |
|---|---|
| c. Kitchigami Regional Library Capital Appropriation Project - Discussion on Purchase Agreement for 17 Summit Ave and Real Estate Inspection Report<br><a href="#">FullReportForUpload</a><br><a href="#">Draft - Certificate of Survey - Library</a><br><a href="#">Deerwood 10-4-22</a> | 15 - 112 |

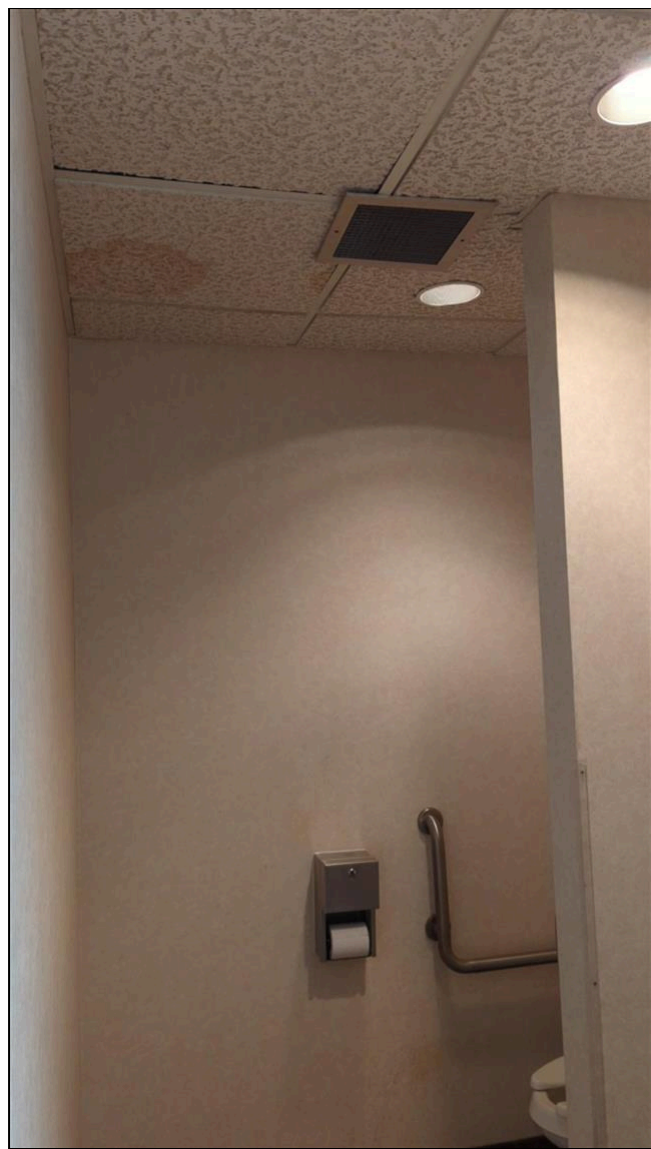
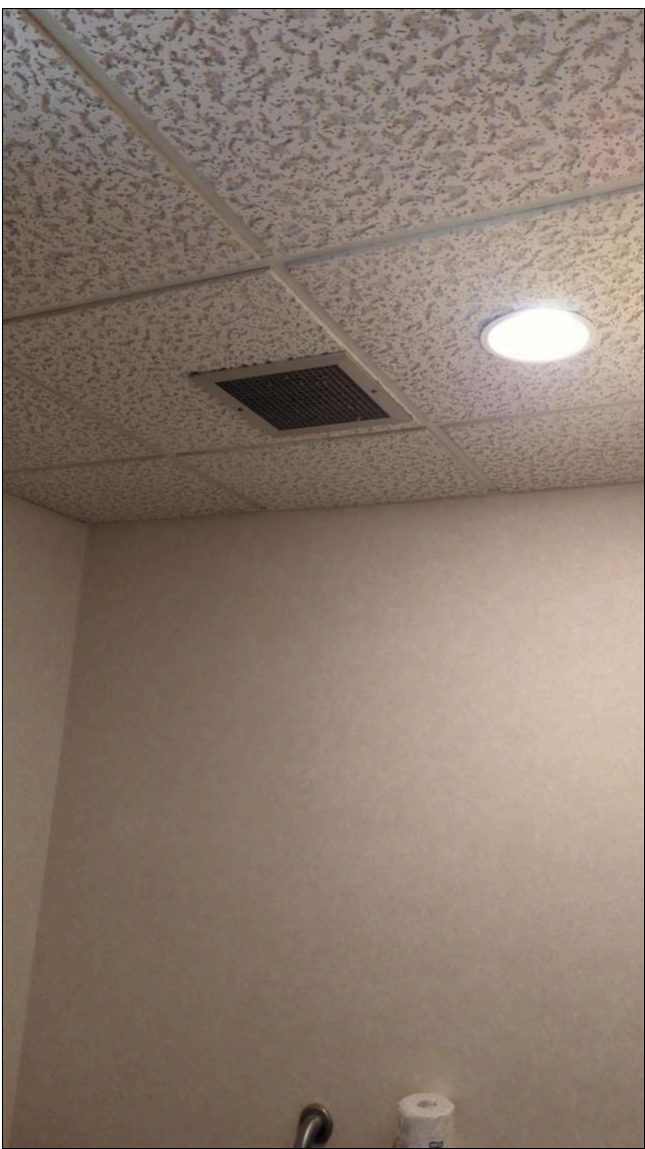
4.9 Item 1(Picture)

The main floor restroom vent fans were not operating.

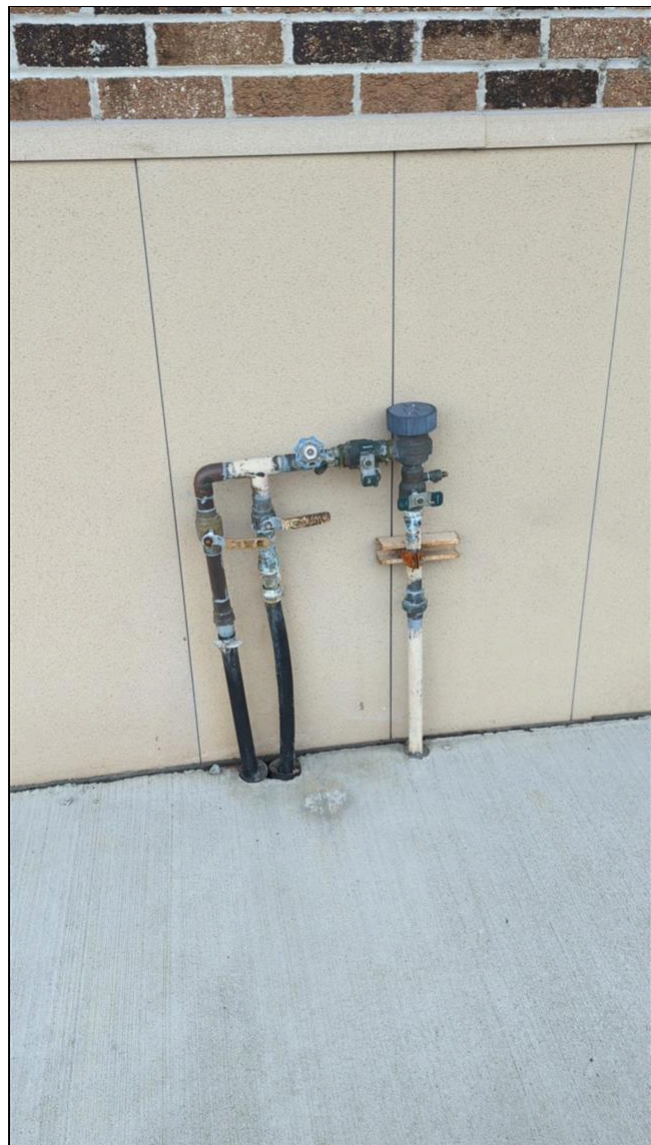
Exterior supply spigots must be drained and winterized annually. The hose bib near the back entry appears to be damaged, and main have frozen in the past based on water damage around the penetration seen from the janitor's closet. Fixtures and supply system could not be fully inspected due to disconnection of the building water supply. A licensed plumber should be present for the re-connection of water to the building to verify functions.

5.1 Item 1(Picture) exterior spigots on W side

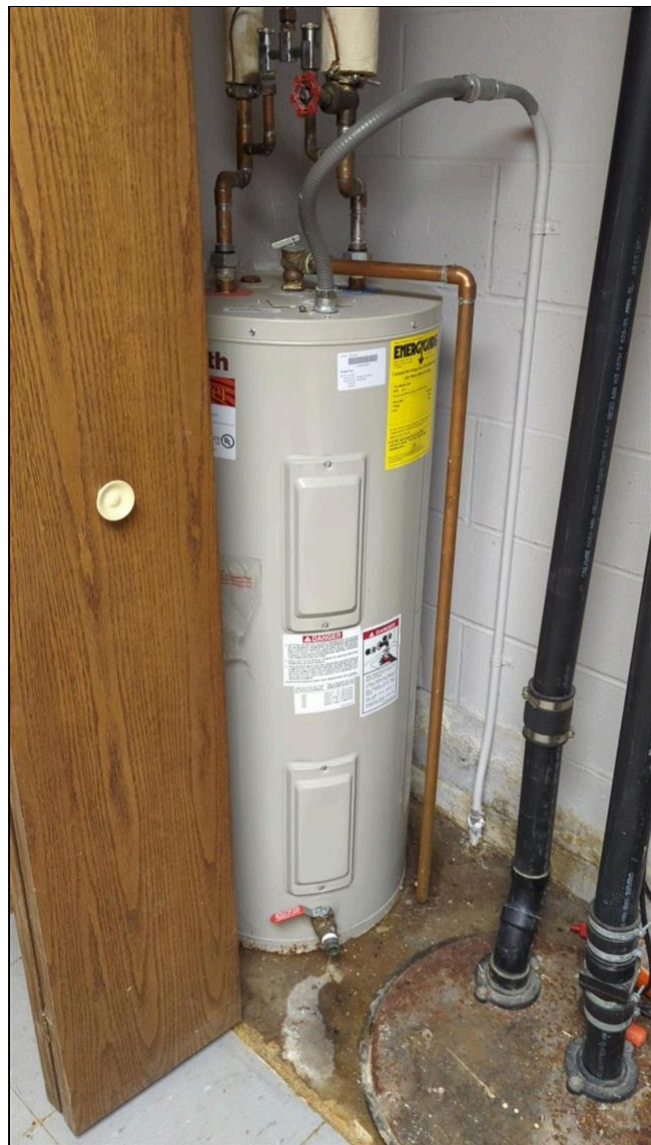
5.2 Item 1(Picture)

The water heater could not be tested for function due to lack of supply. The unit still contains water and is in direct contact with damp concrete-increasing the chance of corrosion and failure. The unit serial number was not visible, but a testing standards date of 1992 indicates that the unit is at least 25 years old and possibly as much as 30. The average service life for a tank water heater is 12-15 years.

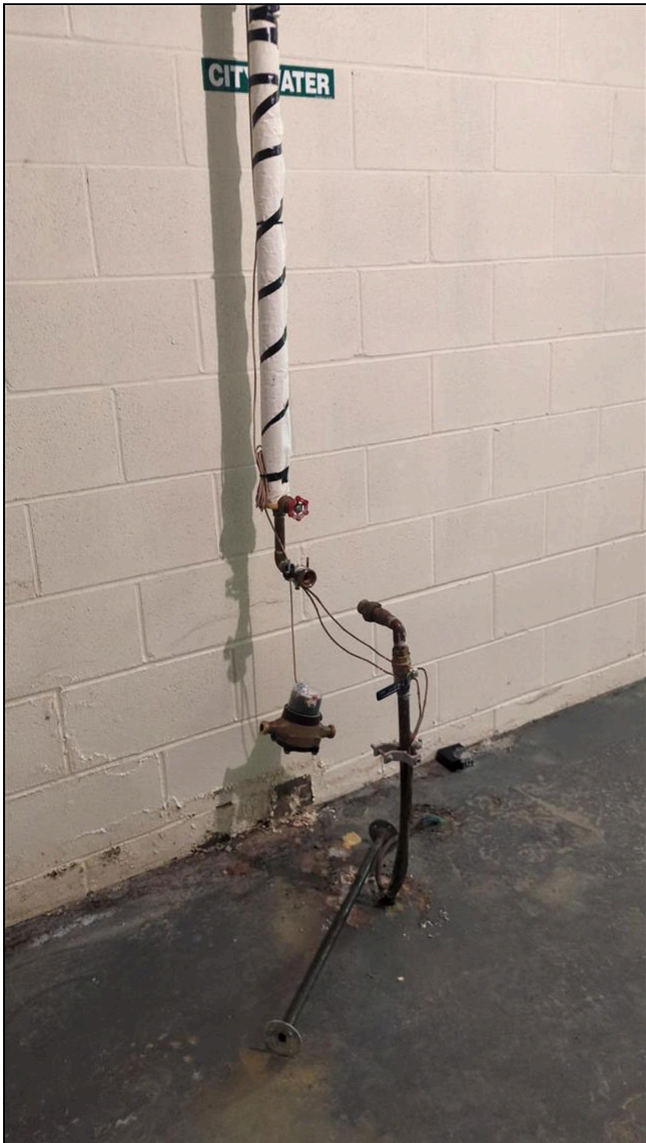
5.3 Item 1(Picture)

**Comments:** Inspected, Tradesman Recommended  
The main water valve is located in the NW corner of the basement and was turned off and disconnected at the time of inspection.

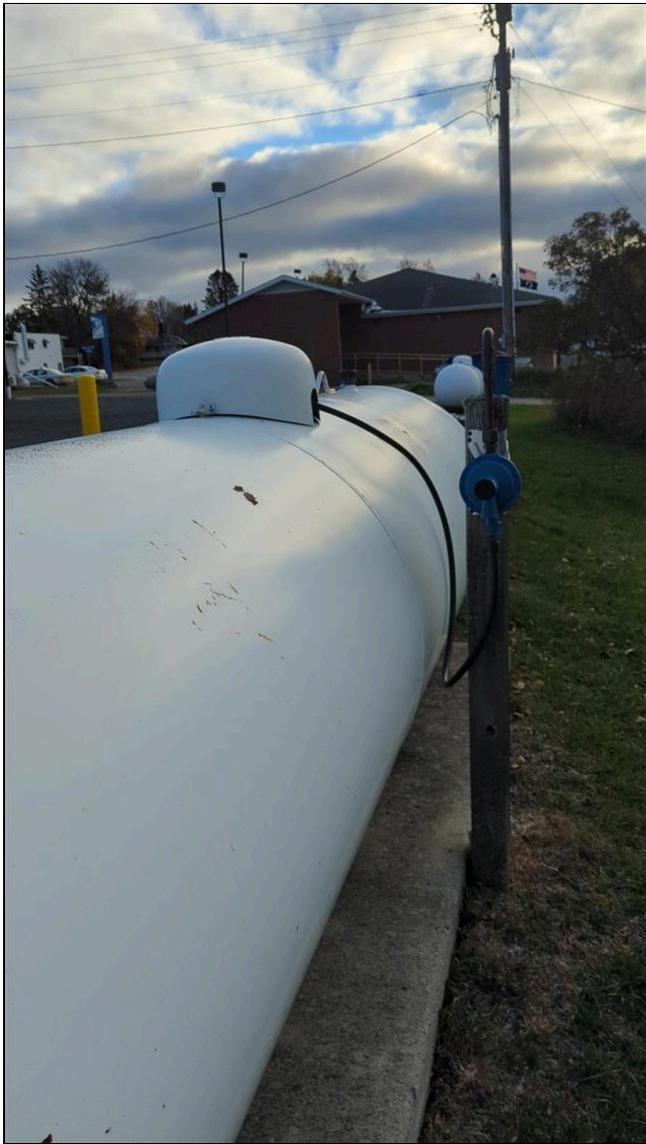
5.4 Item 1(Picture)

The LP tank appears to be appropriately vented and located to the S of the building and parking lot. The tank was at approximately 28% capacity at the time of inspection. There is a cracked regulator weather cover on the supply line to the E RTU on the roof, replace the cover.

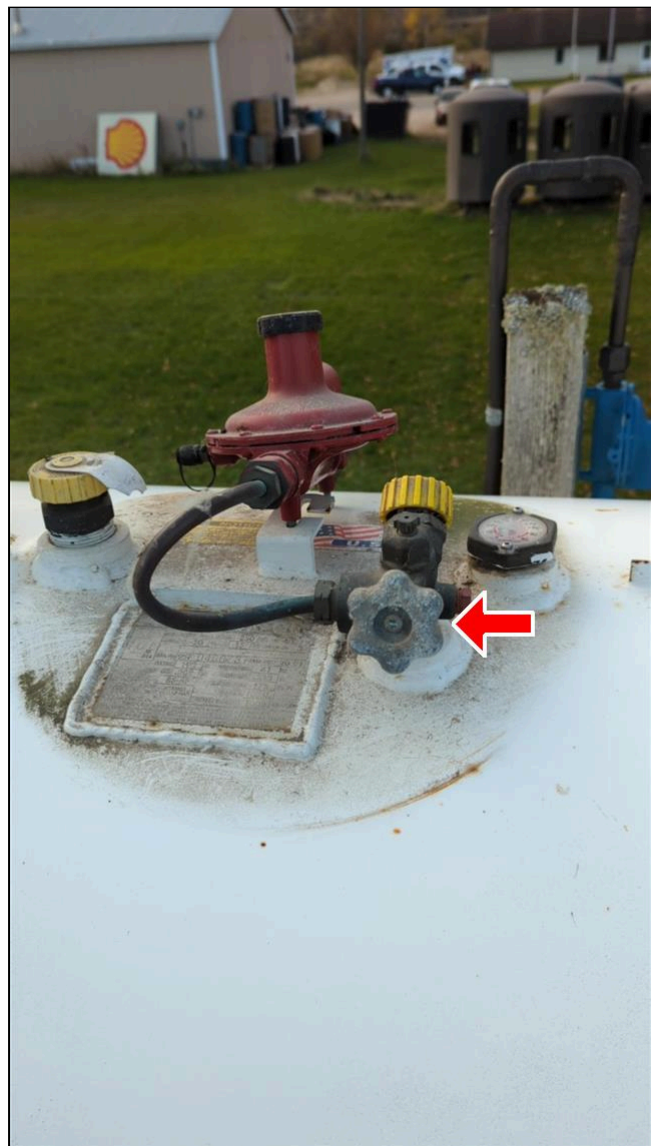
5.5 Item 1(Picture)

The main fuel valve is located below the cover on the top of the LP tank. There is an interior main valve located in the basement utility room on the S side of the building.

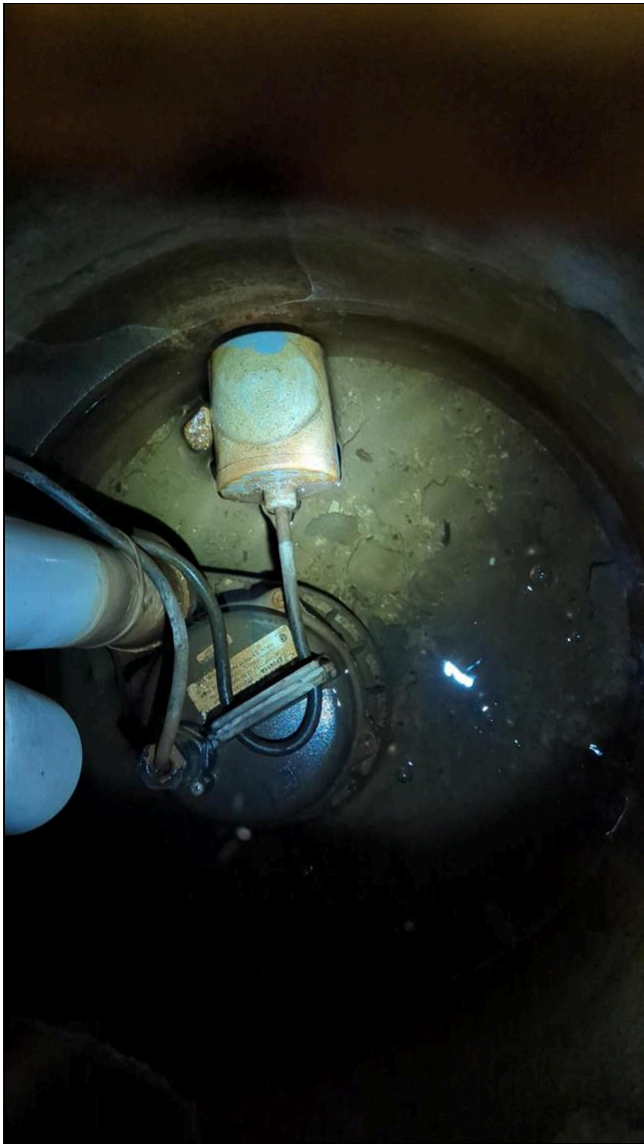
5.6 Item 1(Picture)

The sump pump was functioning normally at the time of inspection.

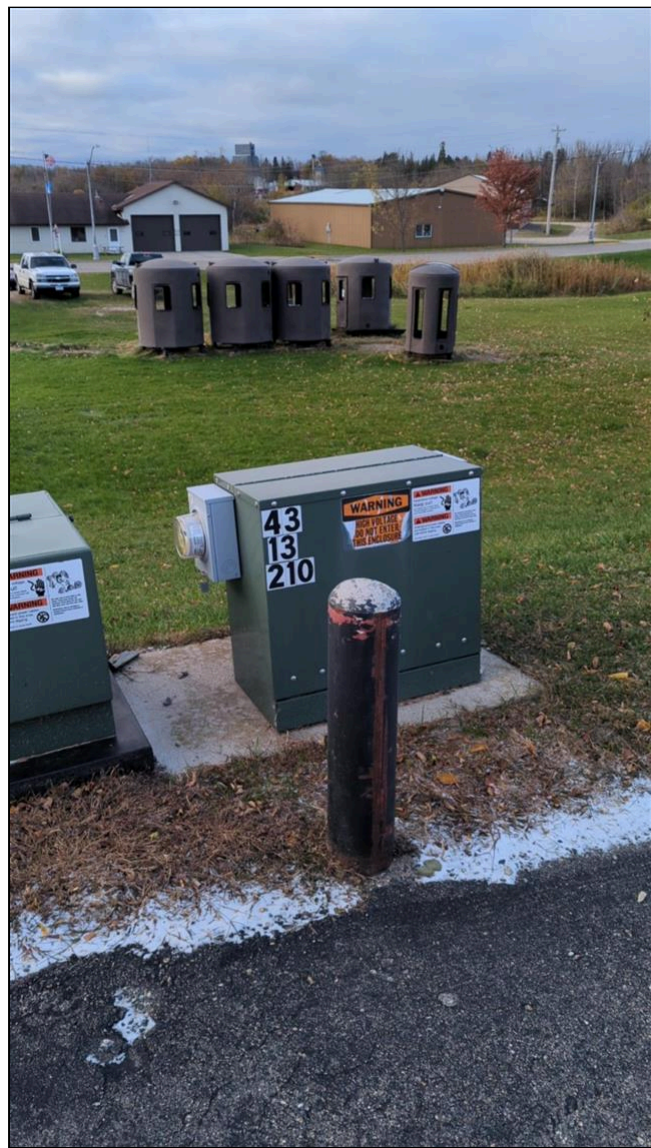
6.0 Item 1(Picture)

The primary service entrance is located on the S side of the parking lot. Two meter boxes are present, one labeled as "OFF PEAK" has the meter removed.

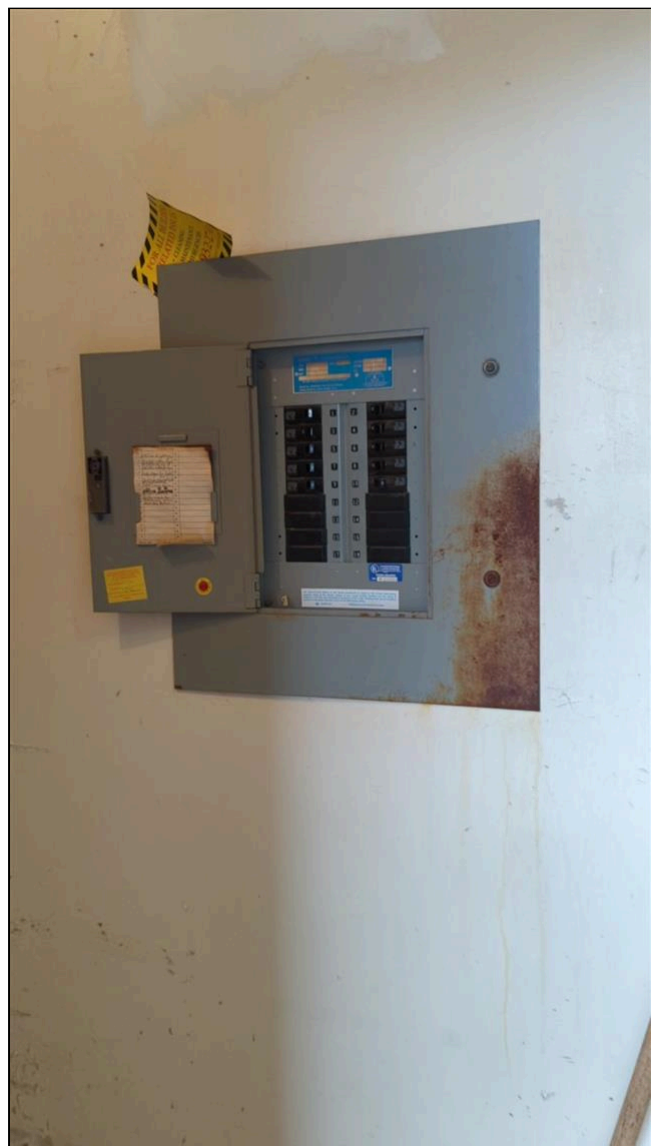
Corrosion on the exterior of the sub-panel located in the janitor closet may indicate moisture damage to the panel. Breaker #10 is in the off position, and is not labeled. All panels have state electrical inspection stickers. The water heater circuit is off due to lack of water supply. There is an open primary breaker slot in panel PNLP-1 that needs to be covered. Consult with a licensed electrician about the necessary repairs. The electrical system is in serviceable condition.

6.1 Item 1(Picture) janitor closet

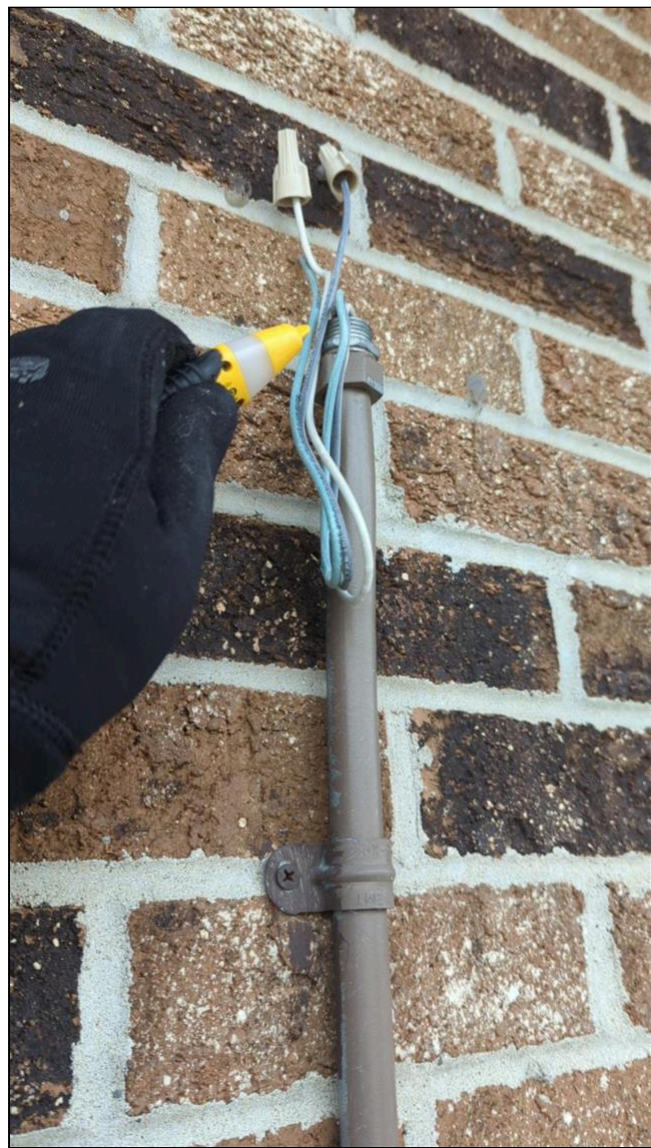
Open wiring on the W side of the building's exterior is not live, but should be secured inside an appropriate junction box. Much of the building's low and non-voltage wiring is open and non labeled, but is not a safety concern.

6.2 Item 1(Picture) W side of building

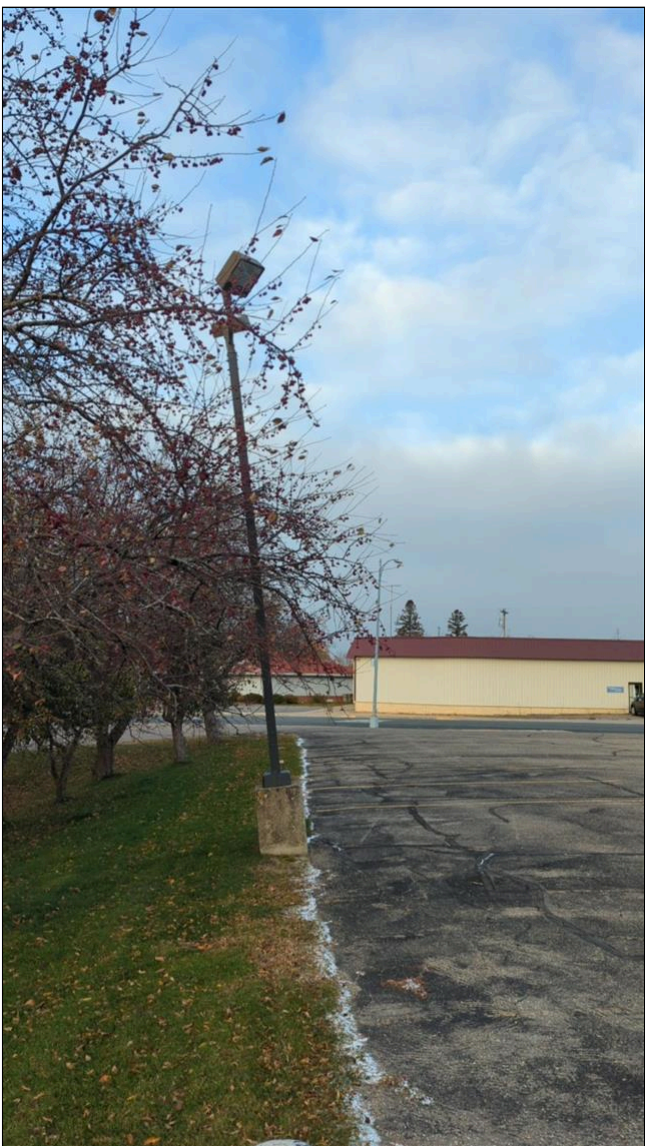
There is a missing soffit light trim on the exterior S side of the building. The S parking lot lighting foundation is out of plumb. There is a very loose receptacle missing its cover in the drive-up teller area.

6.3 Item 2(Picture) leaning light structure

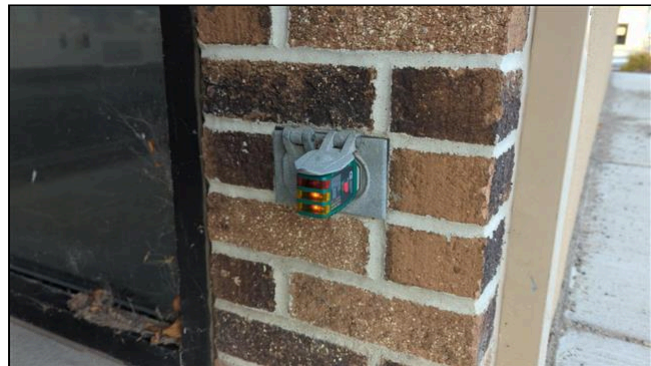
**Comments:** Inspected, Tradesman Recommended  
The exterior receptacles near the front and rear entrances are grounded, but NOT GFCI protected. The restroom receptacles on the main floor and the break room receptacle in the lower level are grounded, but NOT GFCI protected.

6.4 Item 1(Picture) Front entry

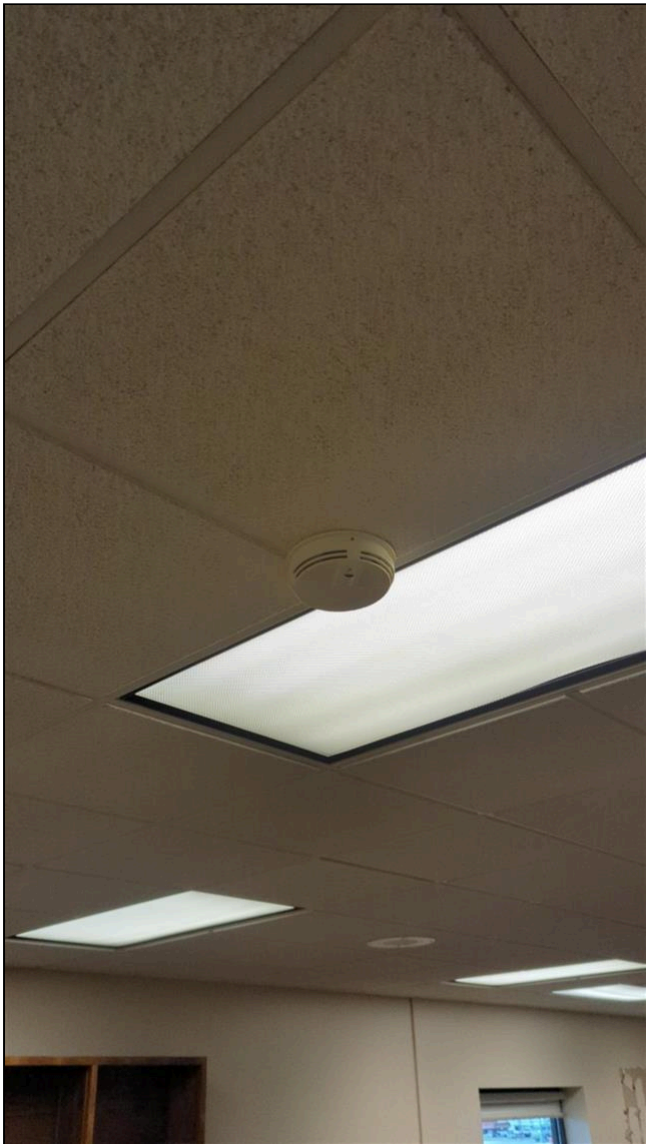
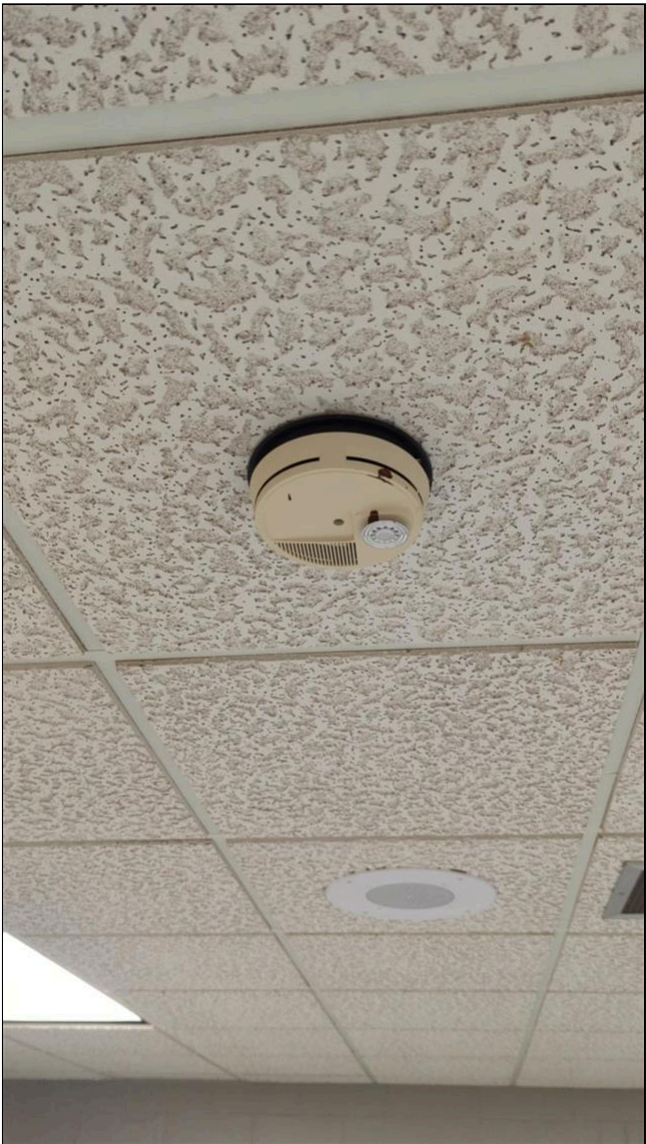
6.8 Item 1(Picture)

The smoke detectors appear to be original to the building and should be updated to modern NFPA standards. The central fire alarm system was not tested. Alarm systems should be tested and documented annually by qualified professionals.

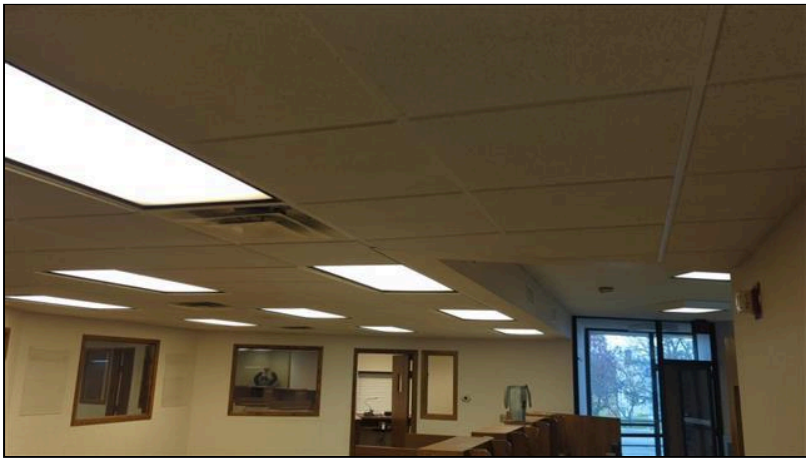
7.0 Item 1(Picture)

**Comments:** Inspected, Tradesman Recommended  
Interior ceilings are in serviceable condition. Minor repair work to drywall is noted near back entrance. Cosmetic crack in drywall is present at back entrance vestibule. Dust staining is observed around forced air supply terminals throughout building. Moisture stains are observed: inside the men's room on the first floor, near the drive-up teller work station, and above the ceiling on the common wall shared with the neighboring building. The stained areas were all dry at the time of inspection and may be related to past or on-going leaks, or condensation related to HVAC ducts or flashing around roof penetrations.

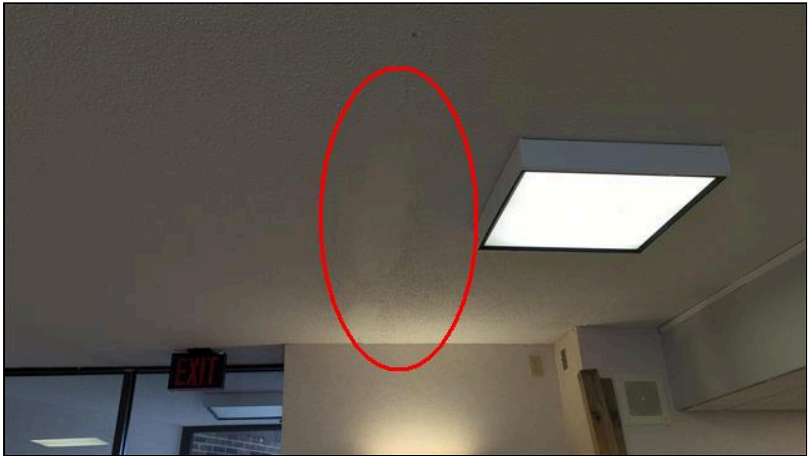
7.0 Item 3(Picture) minor repair

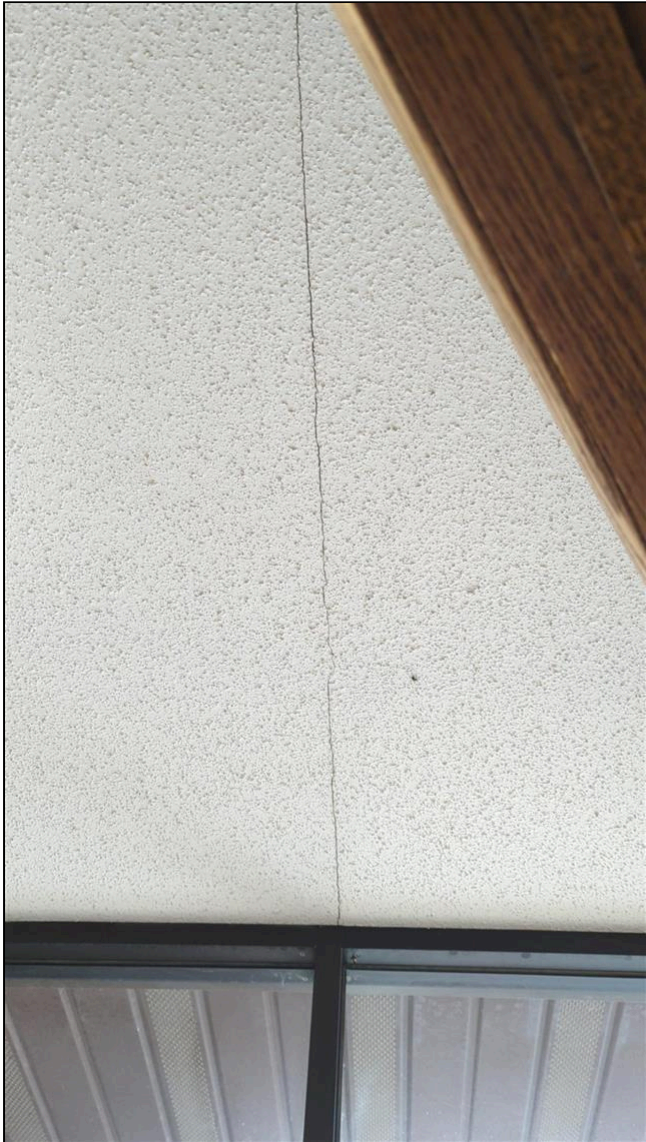
7.0 Item 4(Picture) back entry

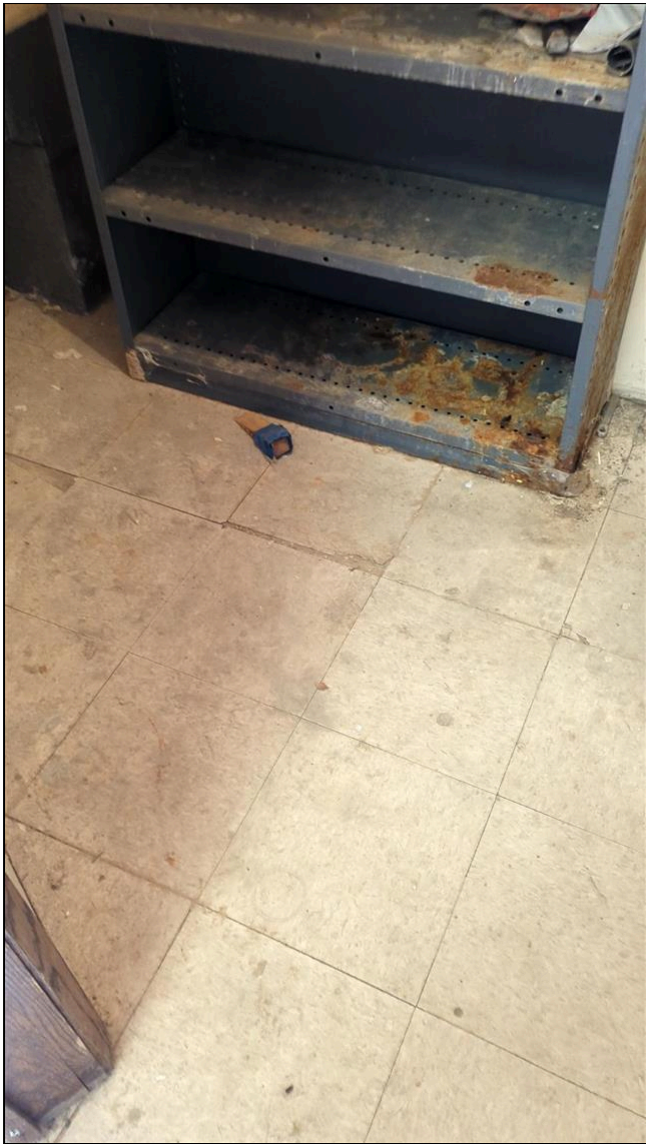
Loose and stained floor tiles are observed in the main floor janitor closet, due to possible past water damage. Back entry vestibule tile is cracked near the exterior door and damaged from the interior door stop. A rodent trap is observed near the stairway in the back work area. No evidence of rodents was observed. Carpeting and baseboard trim are

7.2 Item 1(Picture) janitor closet

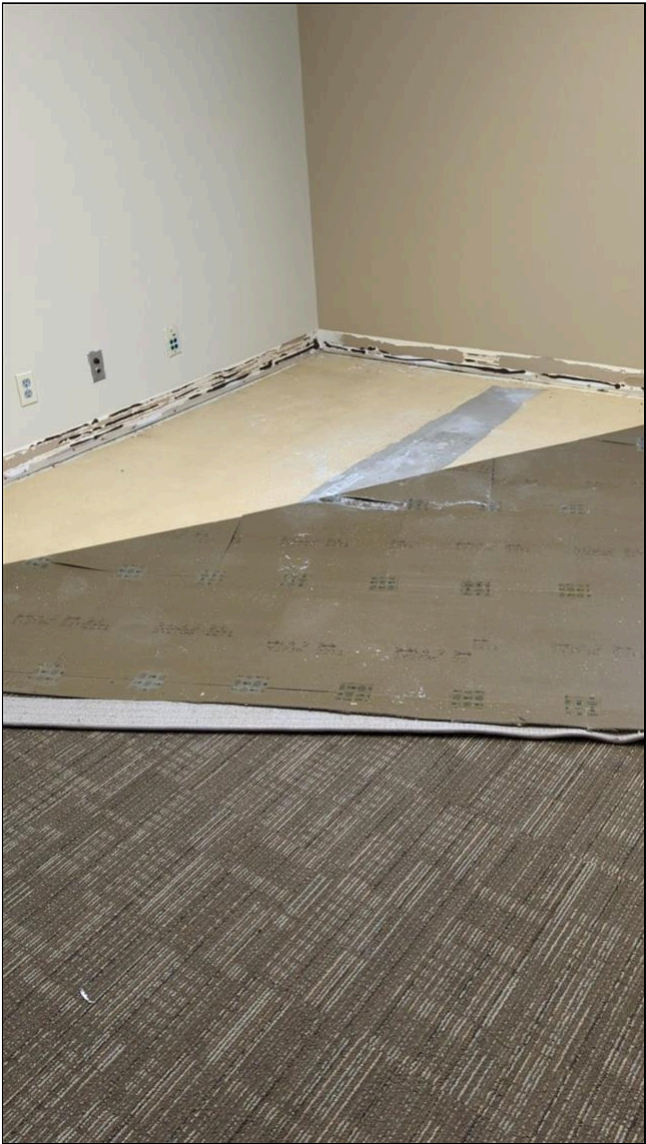
removed in the S office.

7.2 Item 4(Picture) South office
